Addendum: Salvage Report

Historic Structure Documentation

1111 East 7th Street, Georgetown, Texas

March 2019

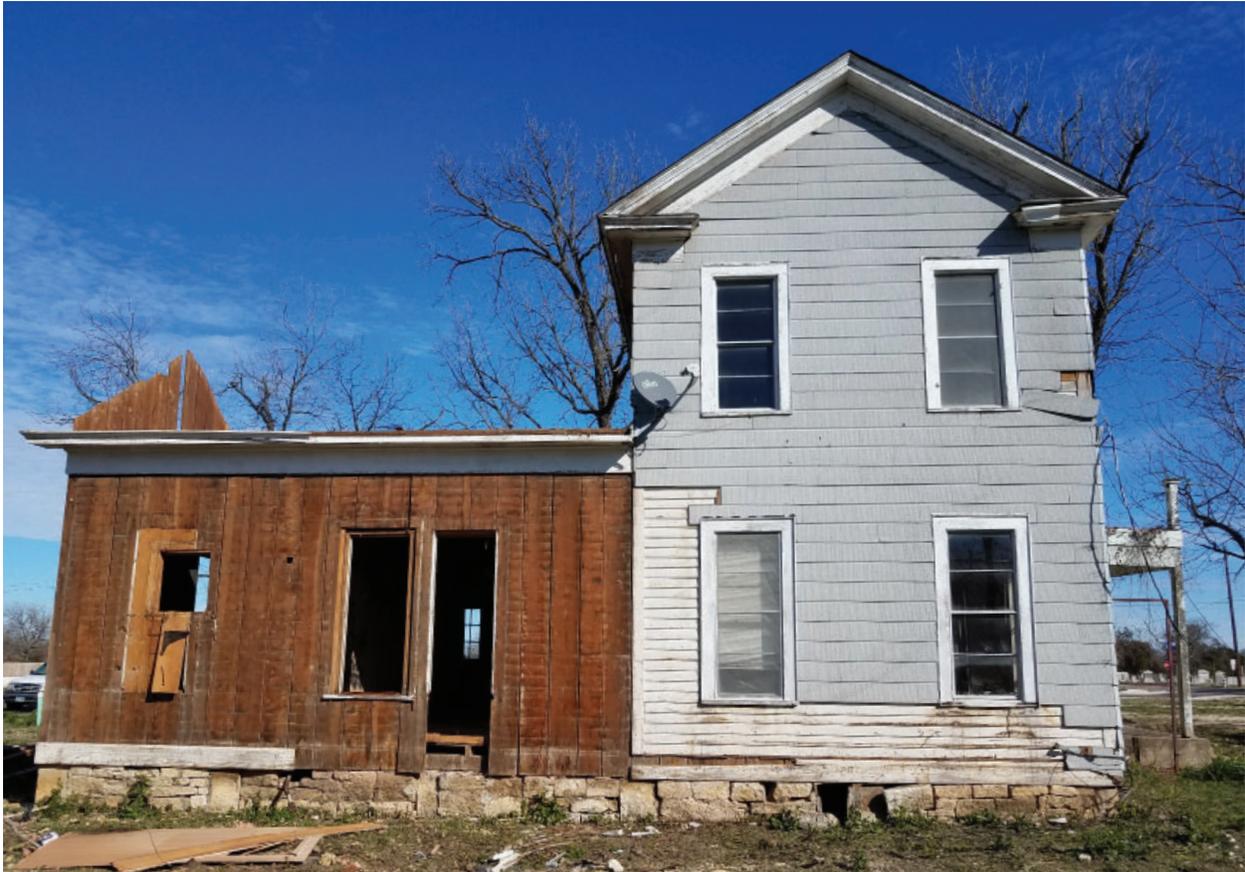
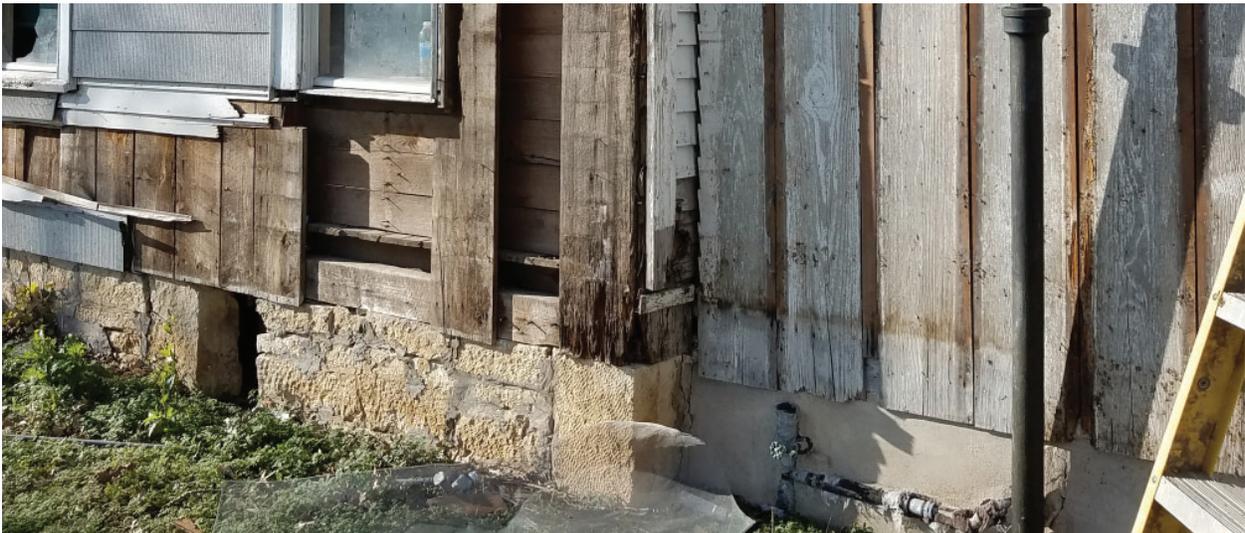
The asphalt shingles were removed to reveal 4" V-groove wood siding, which was all painted white. The wood siding was nailed directly to 1x12 heartwood pine rough-sawn boards (3/4 x 12 on the extension), which extended from the floor beams to the ceiling joists, even on the two-story portion. The wood siding split and cracked when removed and parts were deteriorated to the point that it was not salvageable.

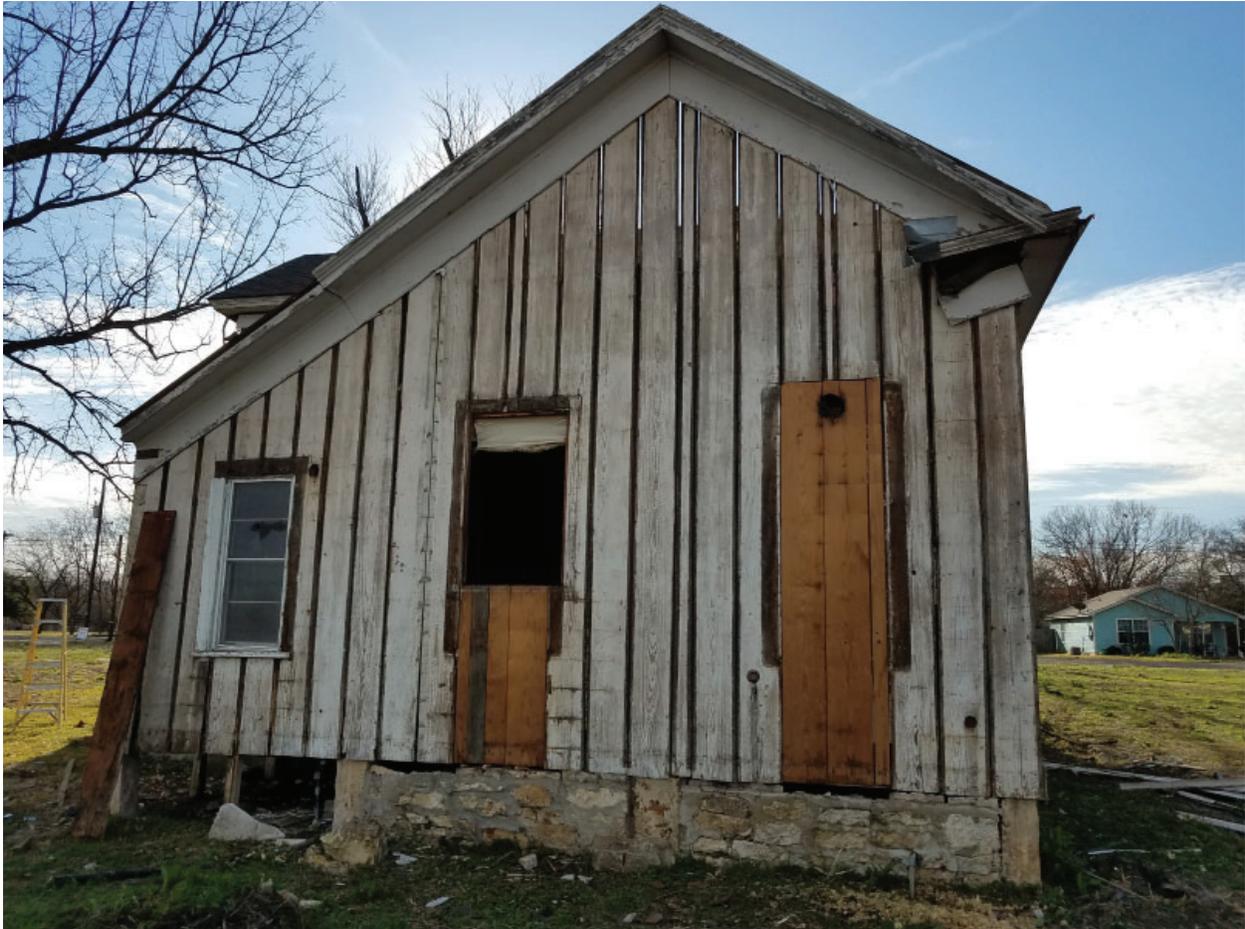
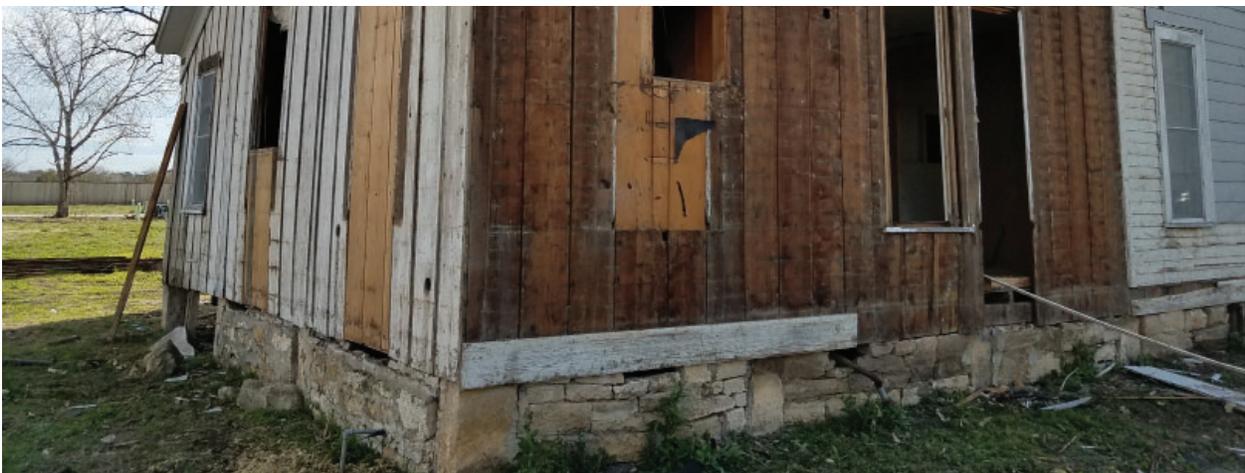
The removal of the wood siding revealed a kitchen window opening that had been closed up for the stove/oven and window openings that had been shortened when the original wood window frames were replaced with aluminum frames, possibly in 1966, the year that a mechanic's lien was filed on the property in favor of the J.A. Collins Lumber Co. and released by The First National Bank of Waco in 1971.

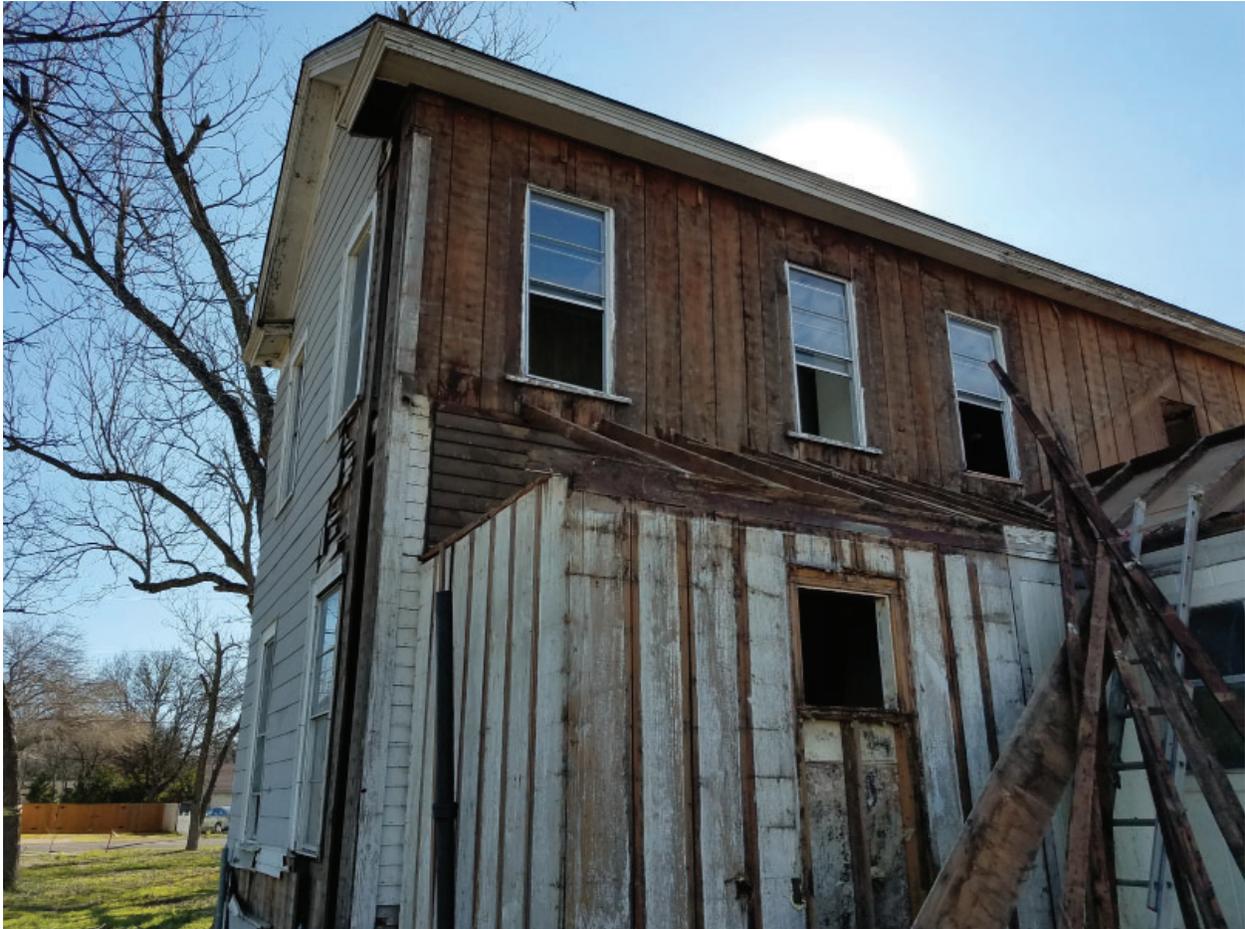
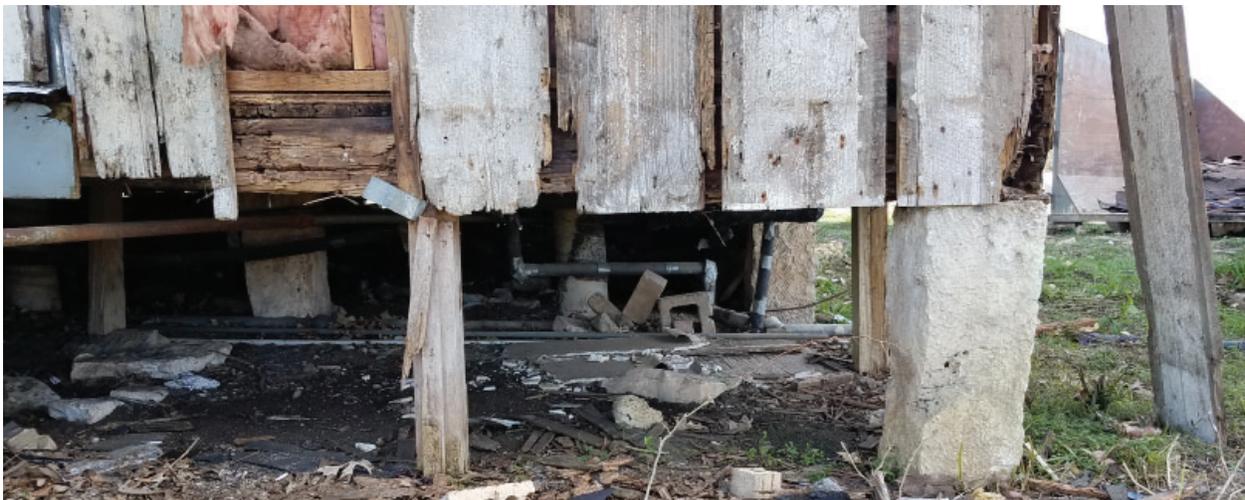
The back porch had been filled in over time and had some of the most extensive water damage and deterioration. It appears that the porch roof and floor had been left in place and the bathroom (above) and water heater closet (below) had been framed from the outside in with 2x4s, insulation and sheetrock.

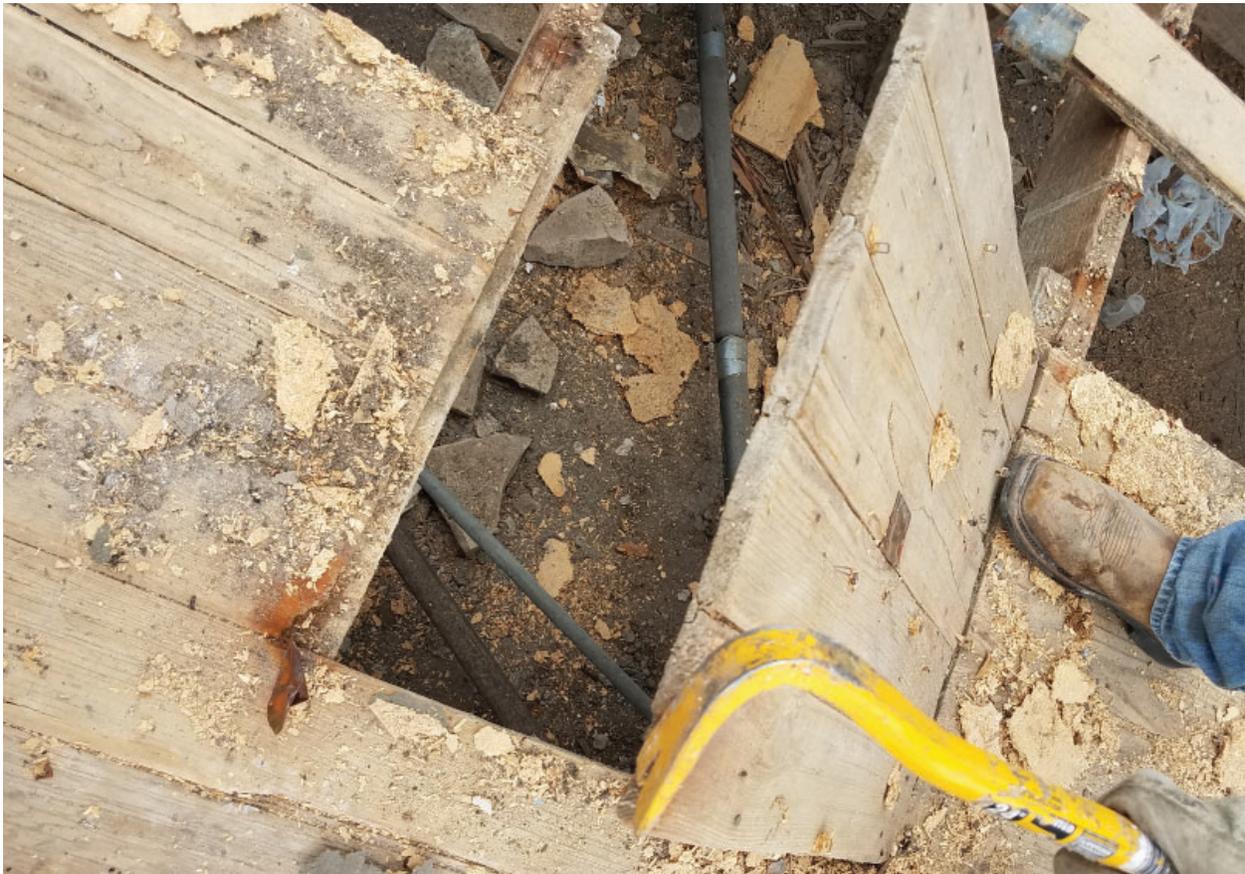
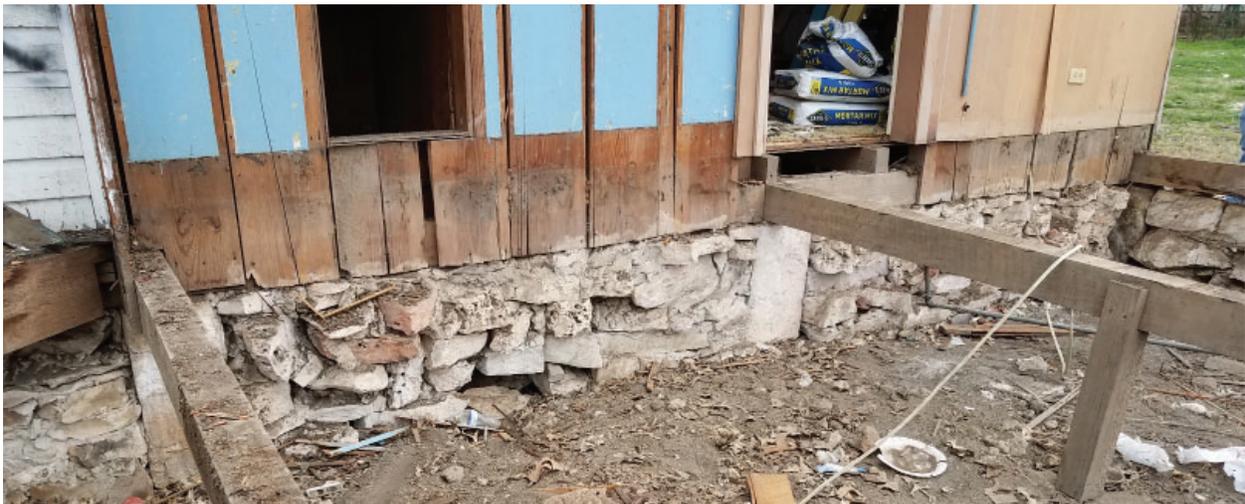
Surprise! There was a trap door in the floor of the kitchen that was not visible until the tongue-in-groove floor boards were removed one-by-one. It was set between two of the floor joists, and constructed with the same tongue-in-groove boards, which is how it was so hard to see until a craftsman popped it up. Below shows the limestone piers and wood beams that supported the dining room and kitchen extension.

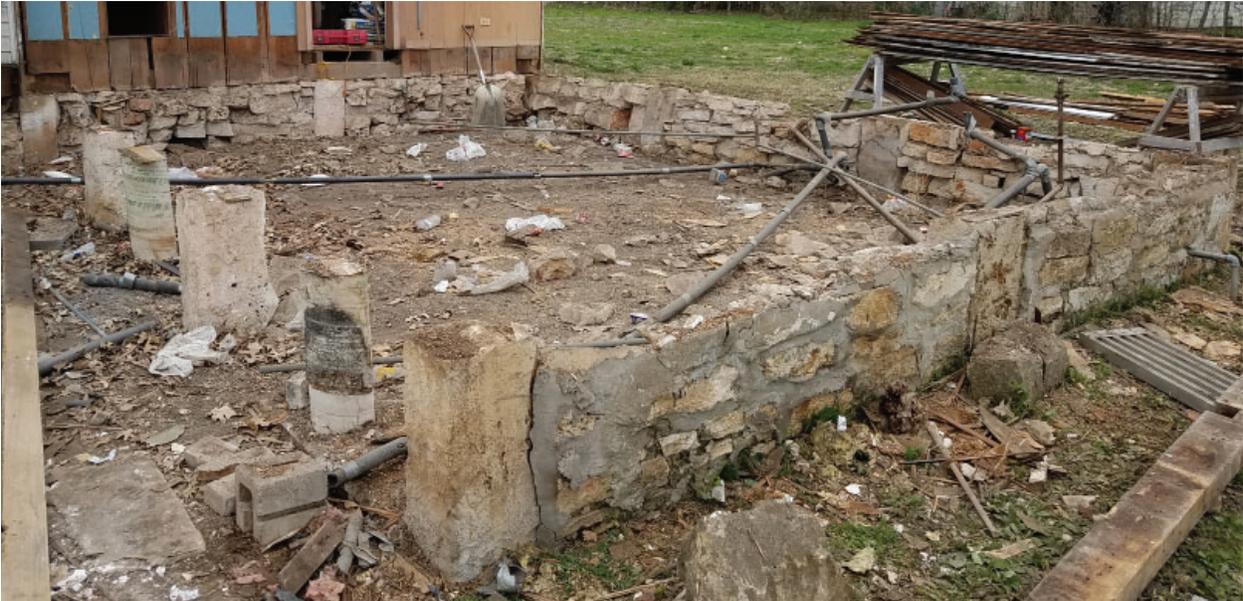
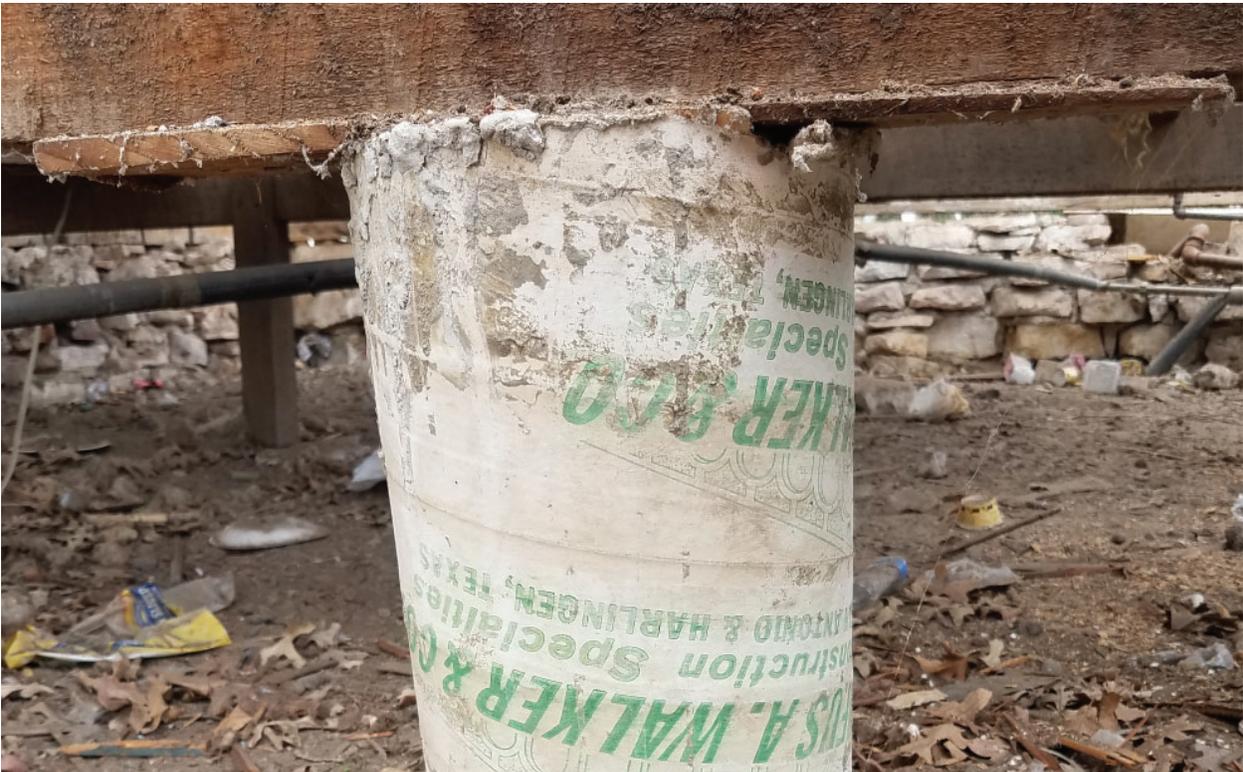
The pier and beam foundation for the extension was supplemented with concrete-filled cardboard tubes that were set under the beam that supported the back edge of the back porch. Weather damage to the wood was evident around that beam, but the date of the concrete tubes is unknown. It may have been part of the remodel work in 1966. Below is a close-up of the cardboard tube supporting that beam.

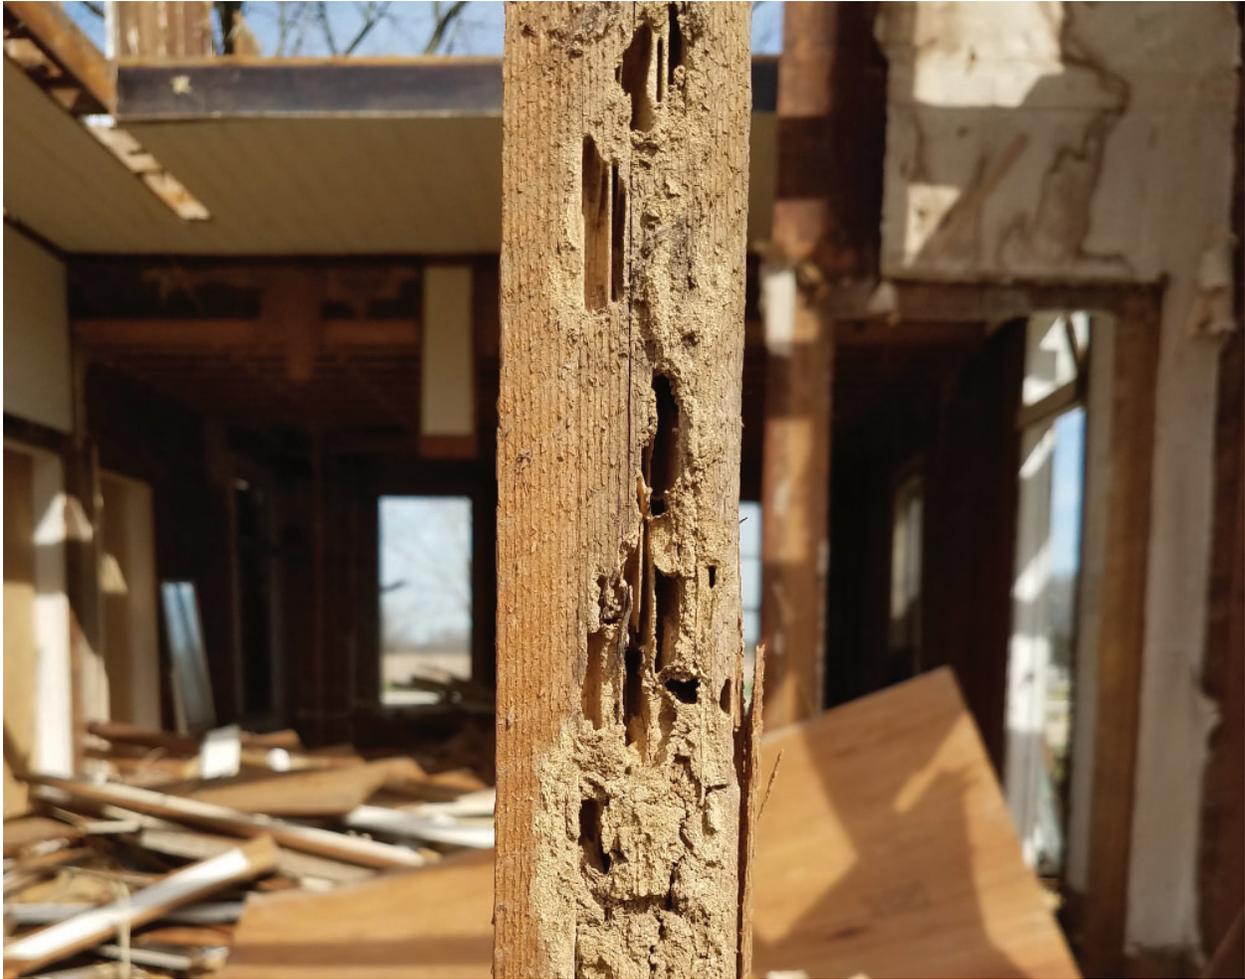
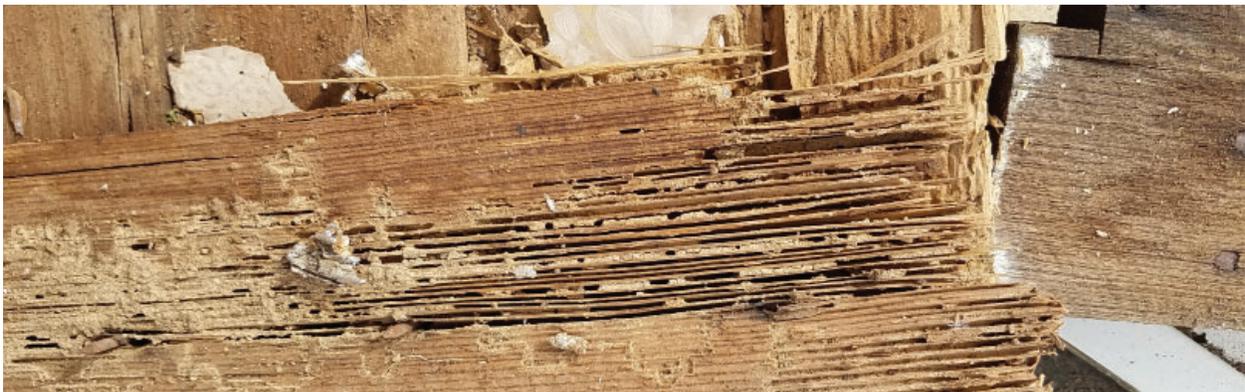
Unfortunately, the west end of the house had significant termite damage in the framing members. While not all of the lumber in the west wall was affected, even the old pine was not immune to the forces of a termite colony, which tunneled through studs, framing members and even some of the foundation beams, rendering them structurally unsound and not of use for salvage.

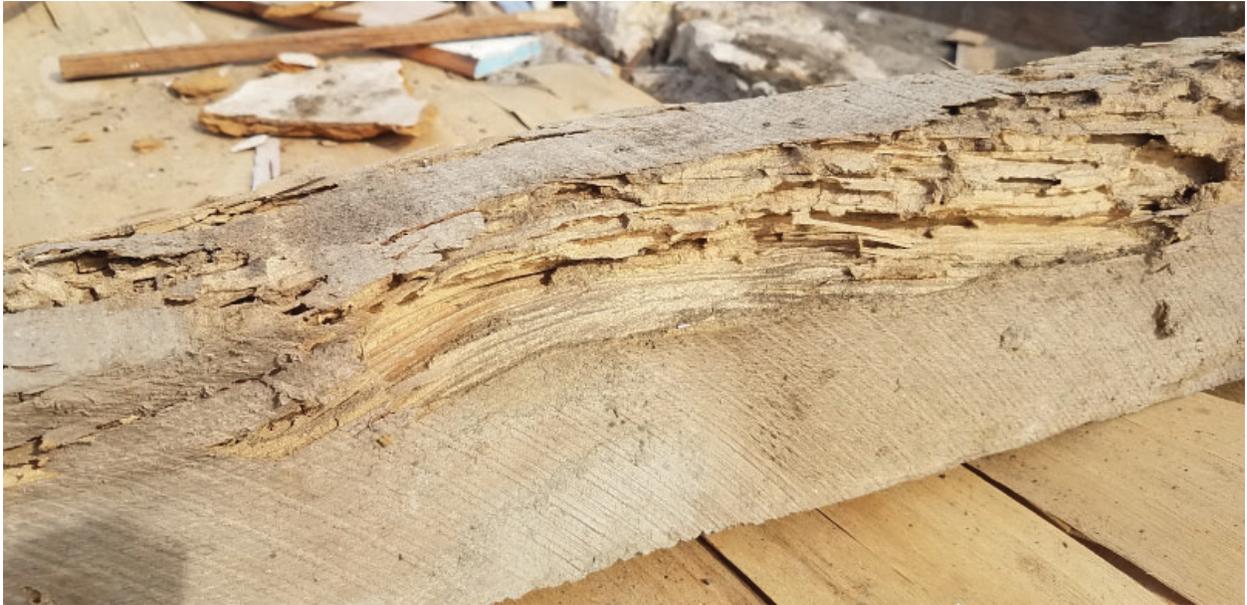
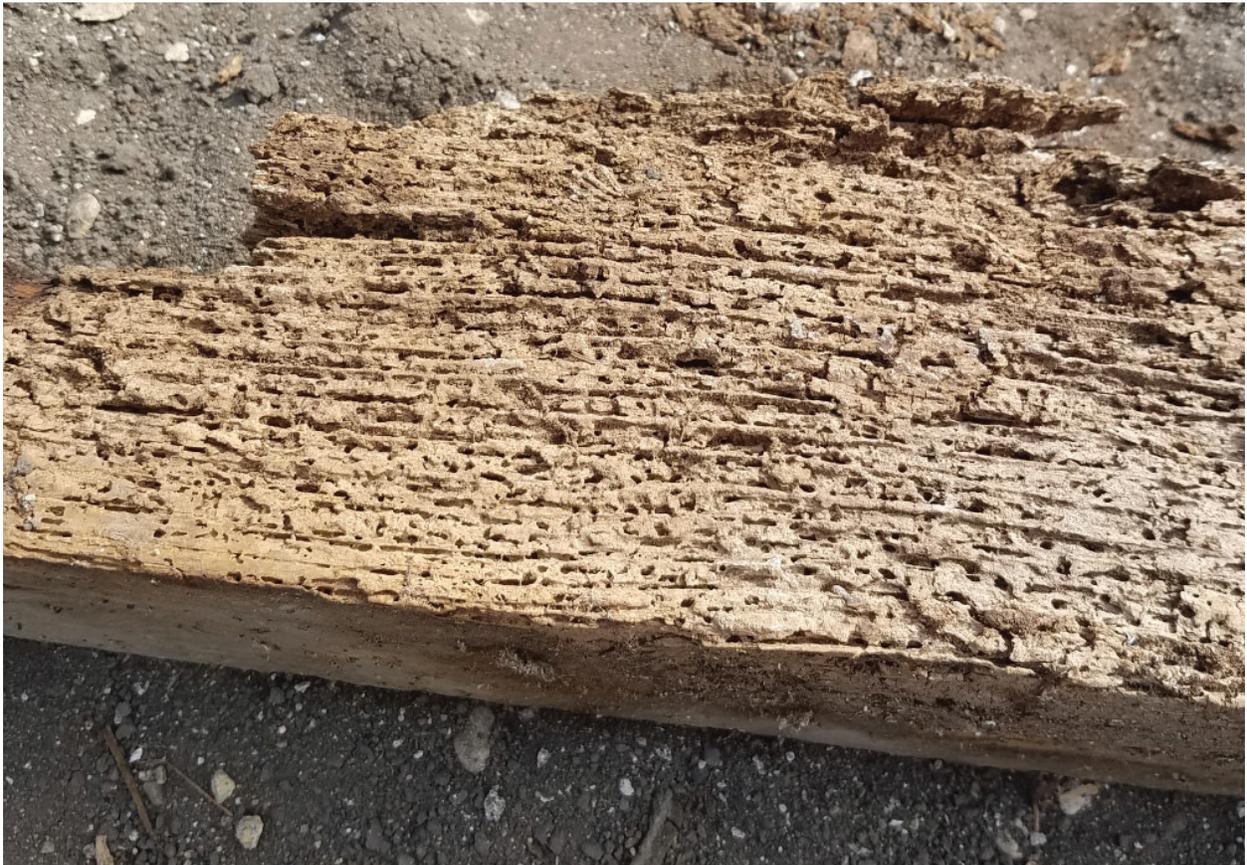
While nature is an artist, it is also at times unfriendly to the maintenance of natural building materials.

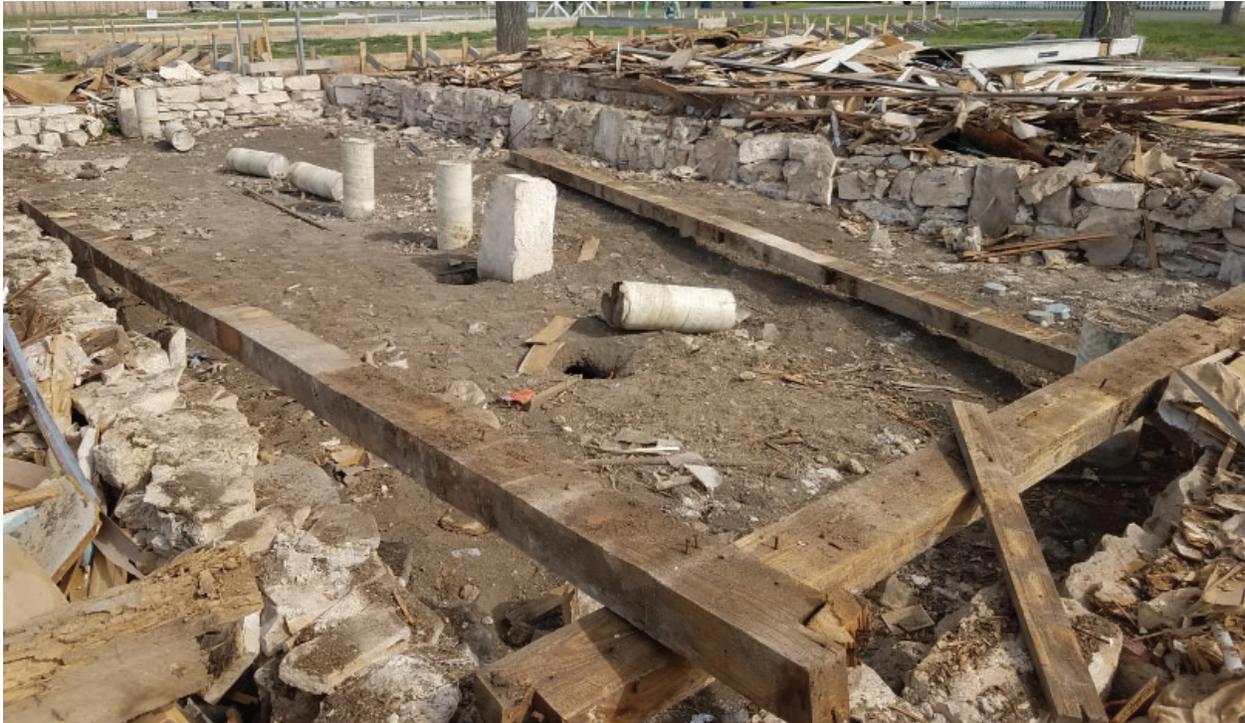
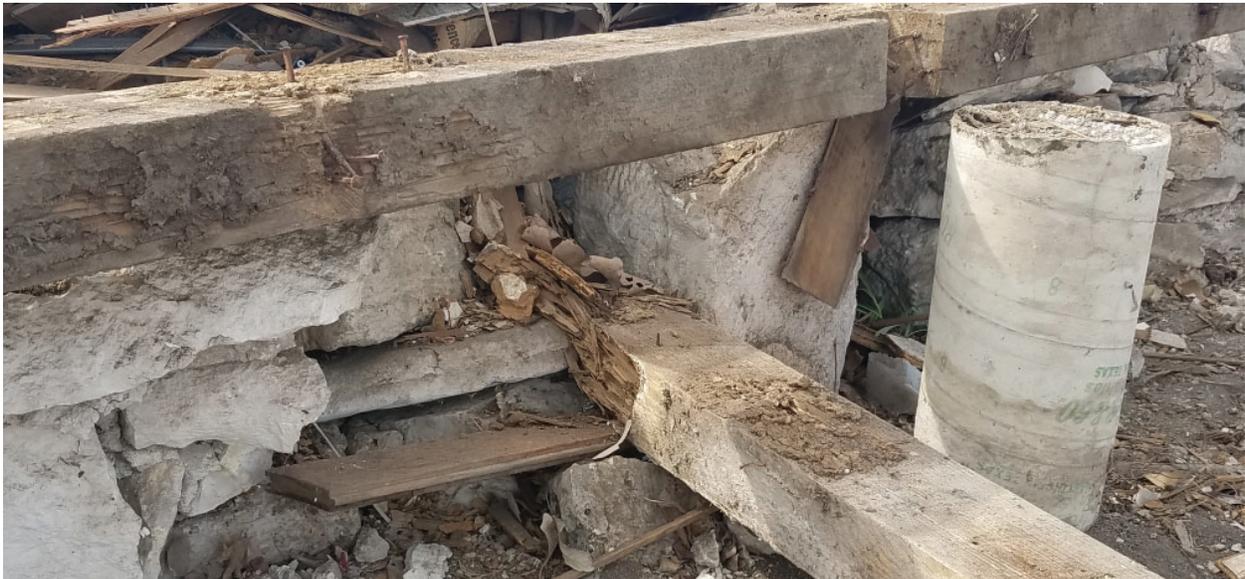
Surprisingly, the same concrete-filled tubes that were found supporting the extension were also found under the center beam of the house. The limestone pier seated just west of center supported the joint in the beams, which were not long enough to span the length of the house as a single piece. There were openings on the east and west ends of the house that allowed access to the crawl space, which is likely how the concrete and tubes were brought in for foundation reinforcing, which must have been a challenging task. Large holes under the house indicate a burrowing animal had taken up residence.
