Addendum: Salvage Report

Historic Structure Documentation

1111 East 7th Street, Georgetown, Texas

March 2019

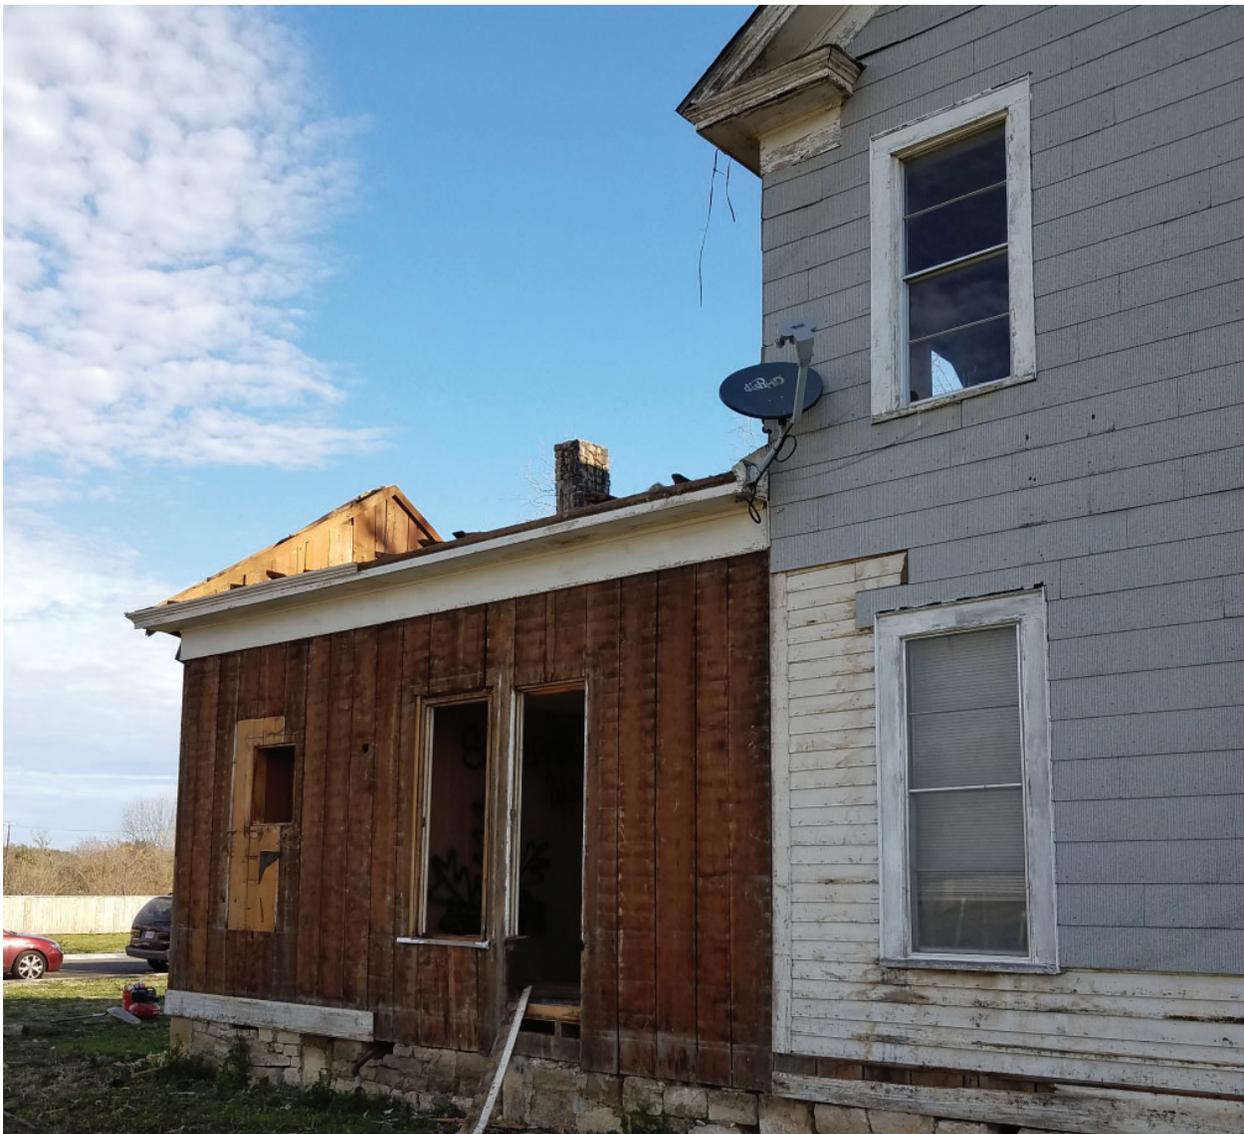
Exterior west wall of residence showing layers of materials being peeled back to reveal the structure..

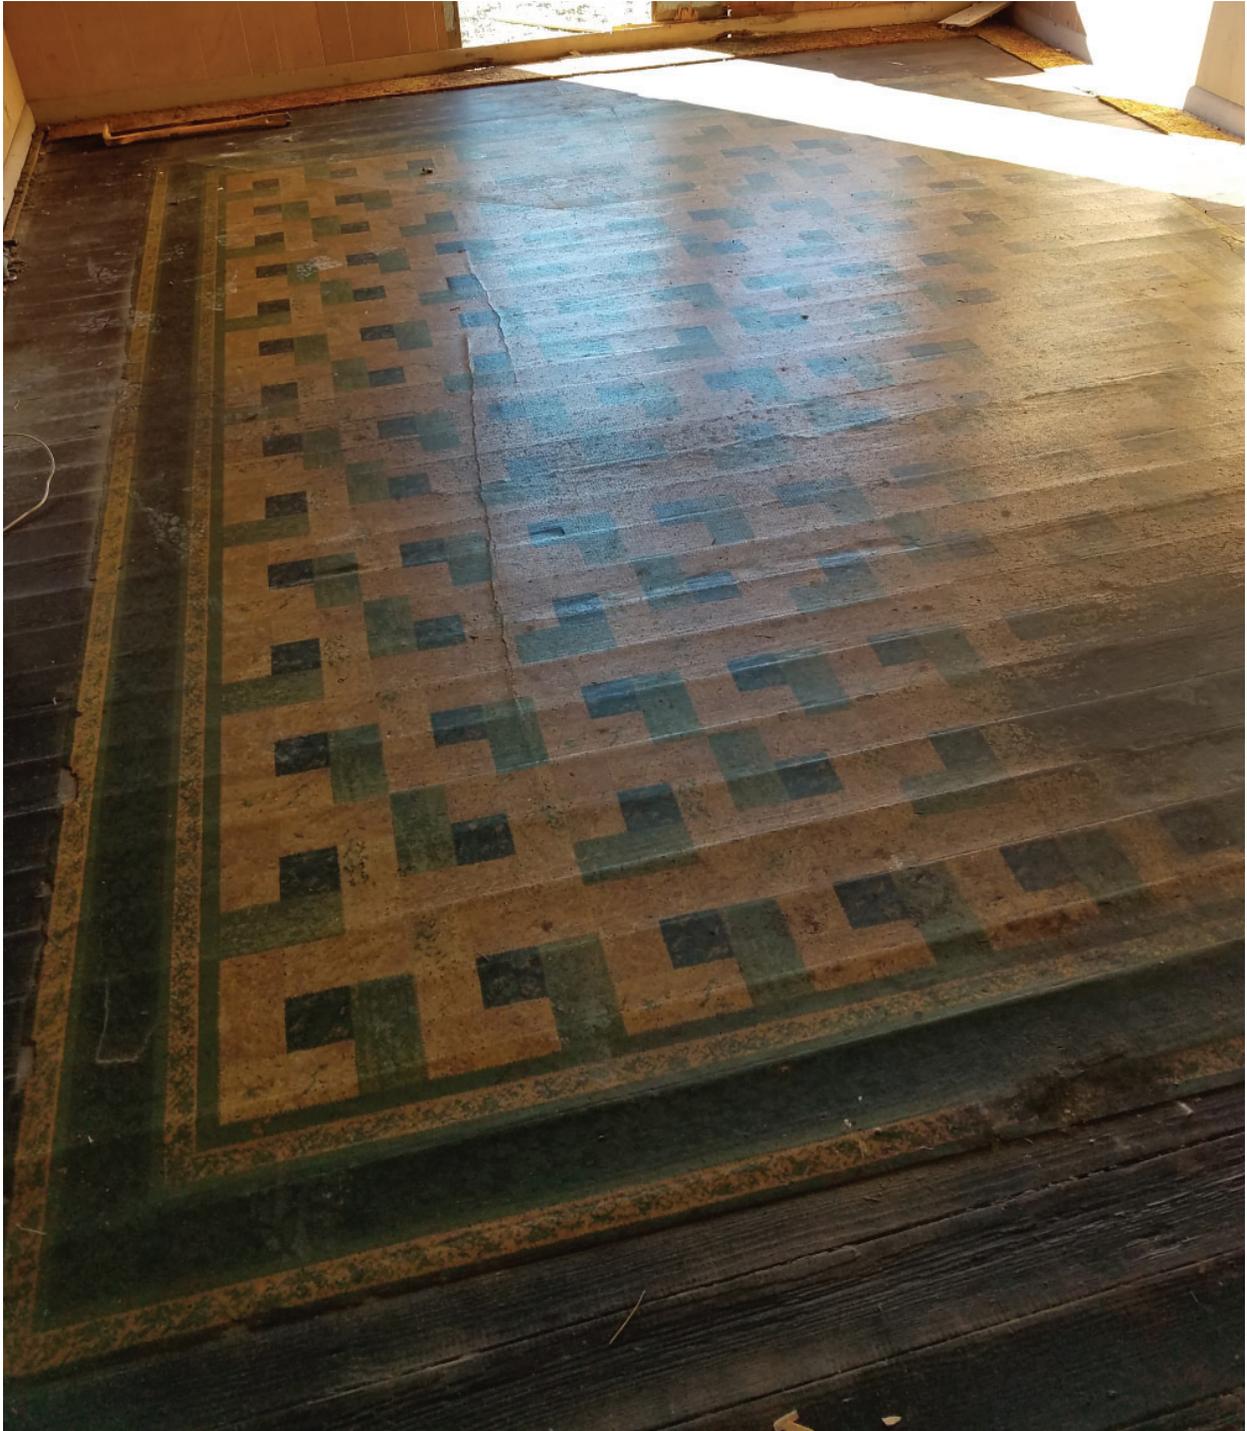
Under two layers of carpet in the dining room (between the west living room and the kitchen) was a surprise - a large linoleum rug that covered most of the floor area. You can read a history of these rugs at Old House Online - www.oldhouseonline.com/interiors-and-decor/history-of-linoleum-rugs.

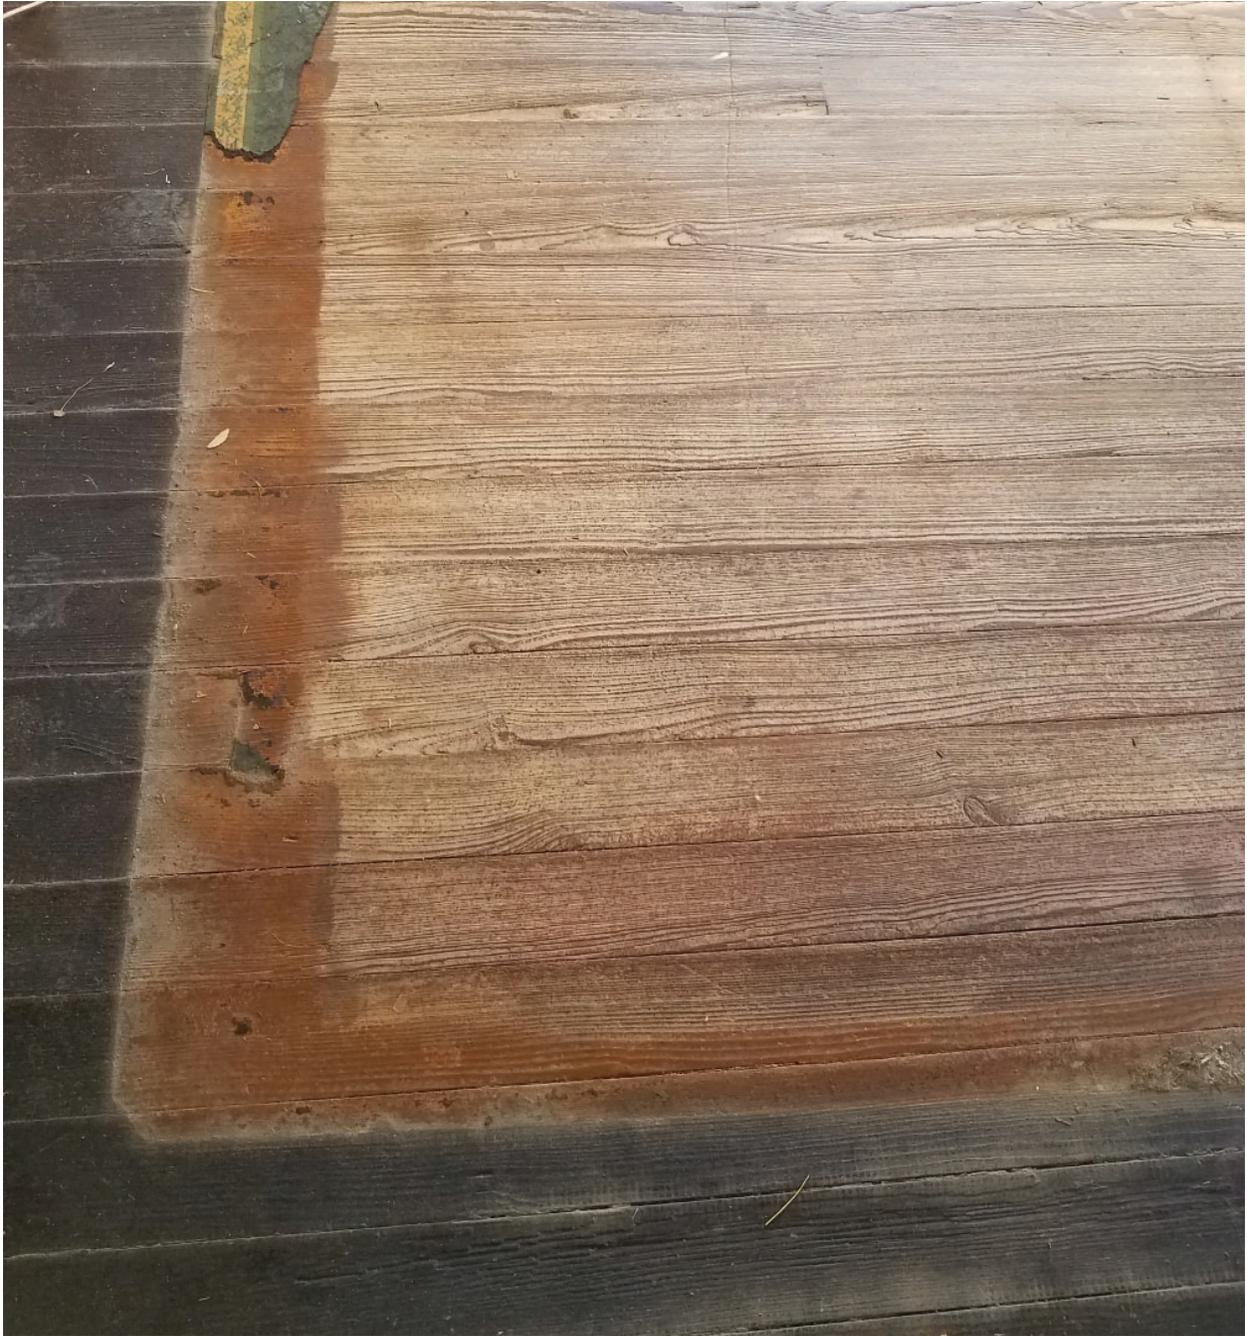
The pine tongue-and-groove floor was stained around and just under the edges of the rug but not underneath, and the floor stain around the edge of the room has aged from a medium brown (visible under the rug edges) to nearly black. This is the same wood floor and stain color that is found in the rest of the house, including the entrance hall and stairs. They might all have started as the medium brown you see in the photo above and darkened over the years. The rug may be from the 1920's or a little earlier.

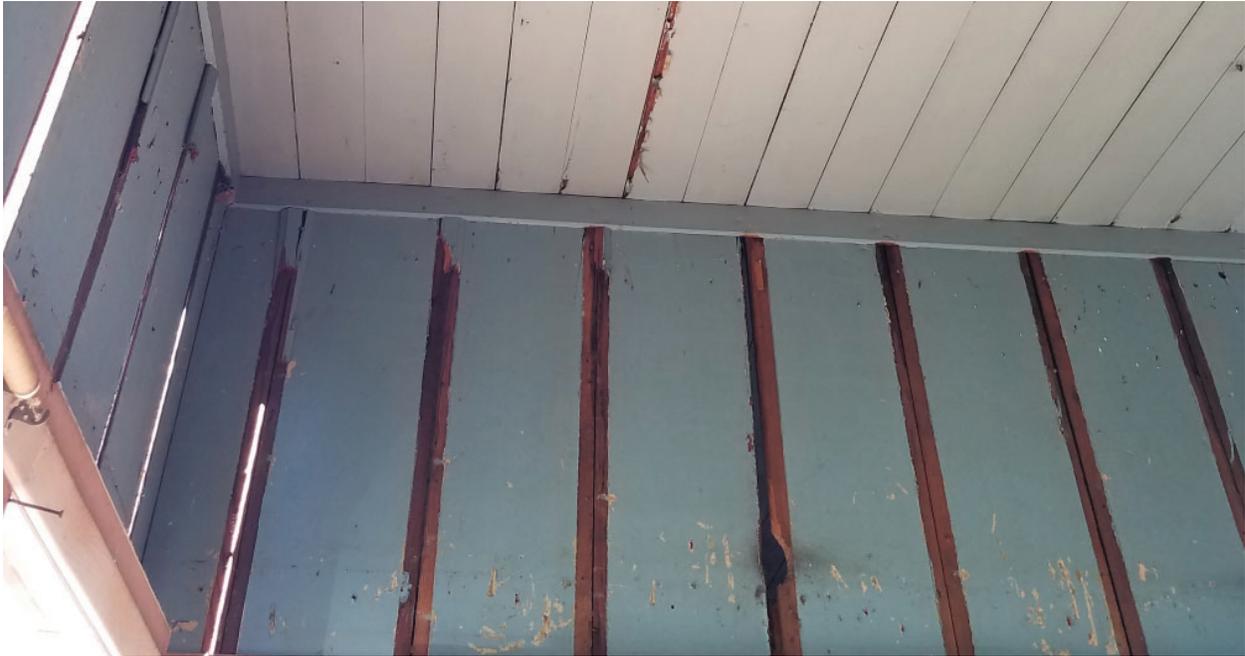
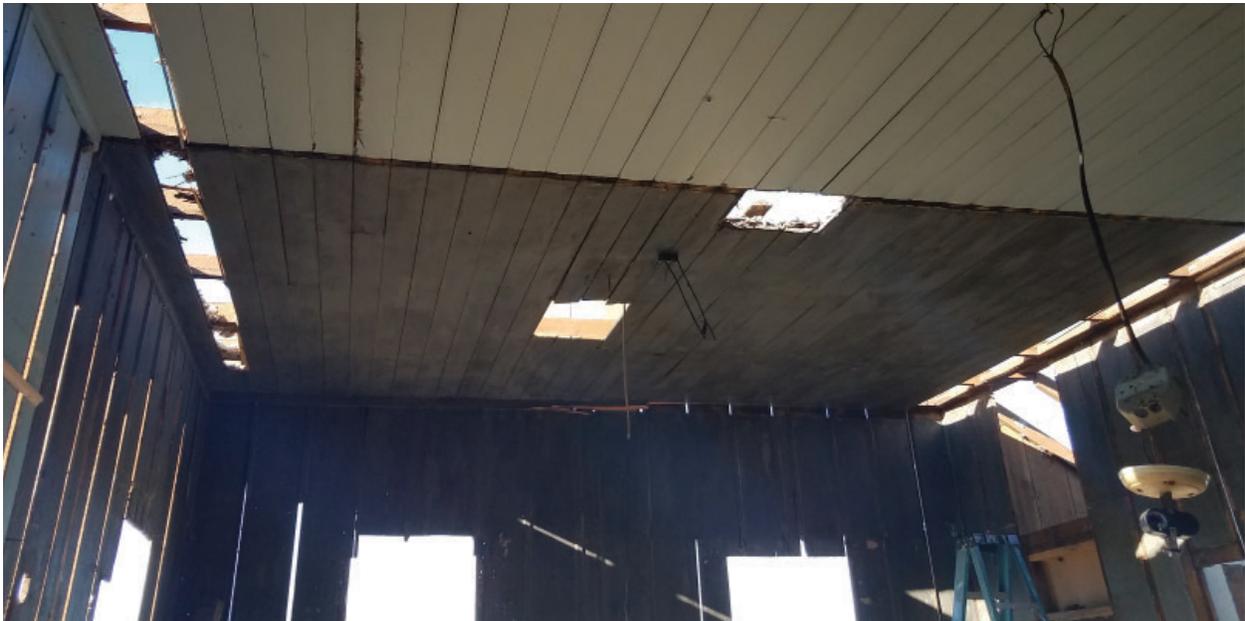
The dining room walls had been covered with thin wood laminate sheets but were revealed to have been painted board and battens with a 4" tongue-in-groove ceiling. The wall boards were the same 3/4 x 12 pine boards that were used to frame the exterior walls of the extension, and the wall between the dining room and kitchen was only a single board in thickness installed after the floors and ceilings were built. Unlike modern house framing convention, this house relied on the exterior for the structure and the interior walls were merely dividing walls. The kitchen was painted the same blue, but smoke from the original cooking method seems to have darkened the blue paint in the kitchen considerably.

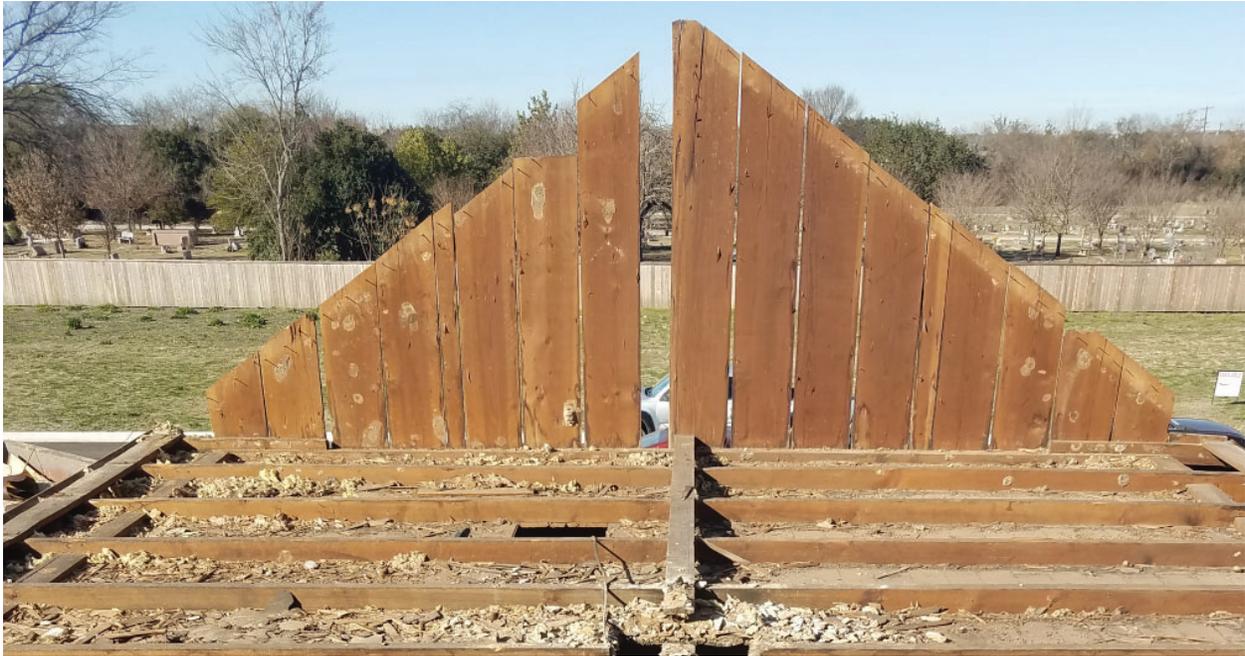
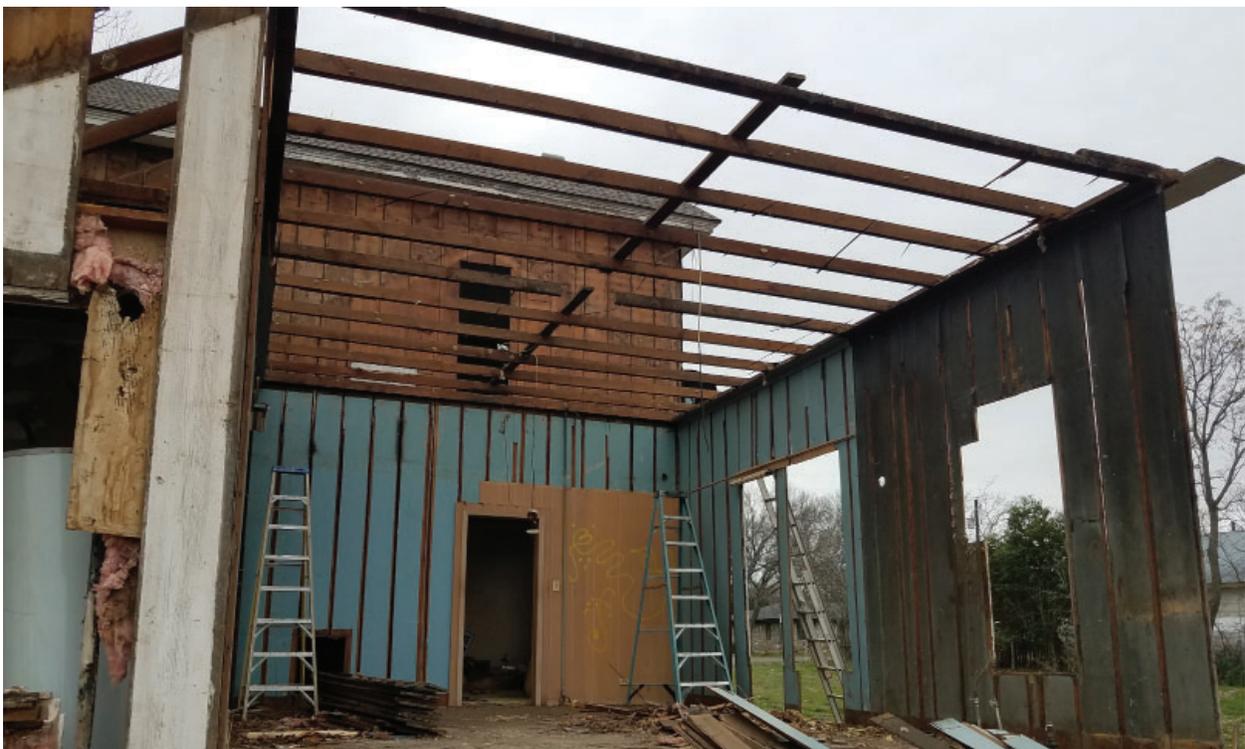
View of the top of the ceiling boards, the ceiling joists and the north exterior wall of the kitchen (above) and the walls and ceiling joists once the north wall of the kitchen was removed (below). The structure was dismantled one board at a time in the opposite order from which it was assembled.

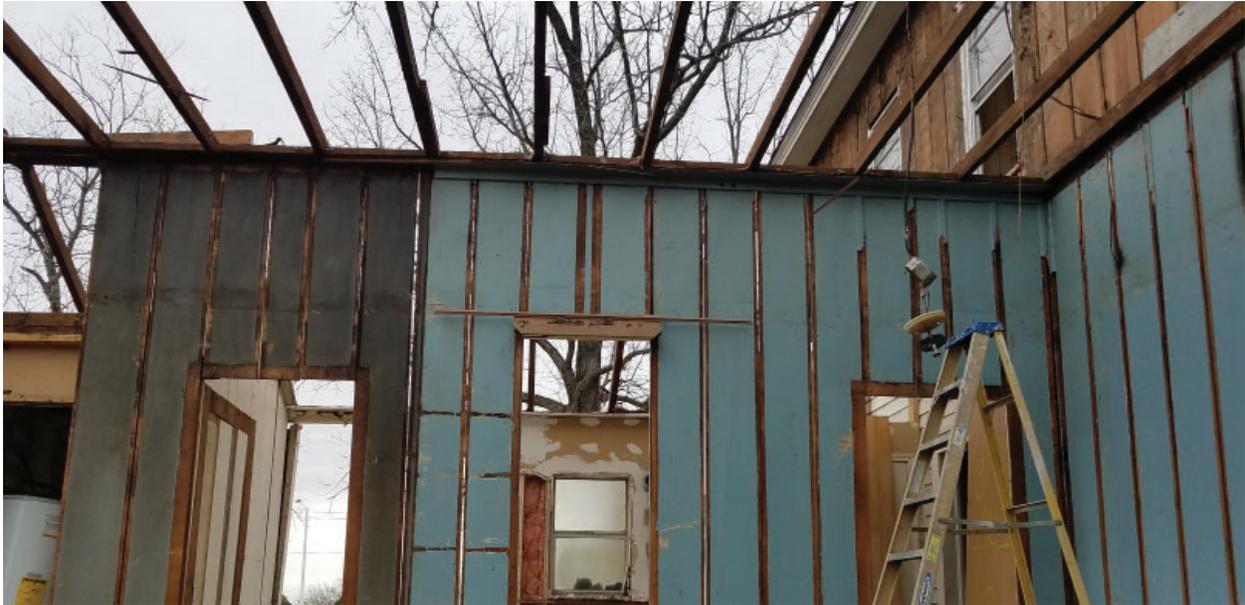
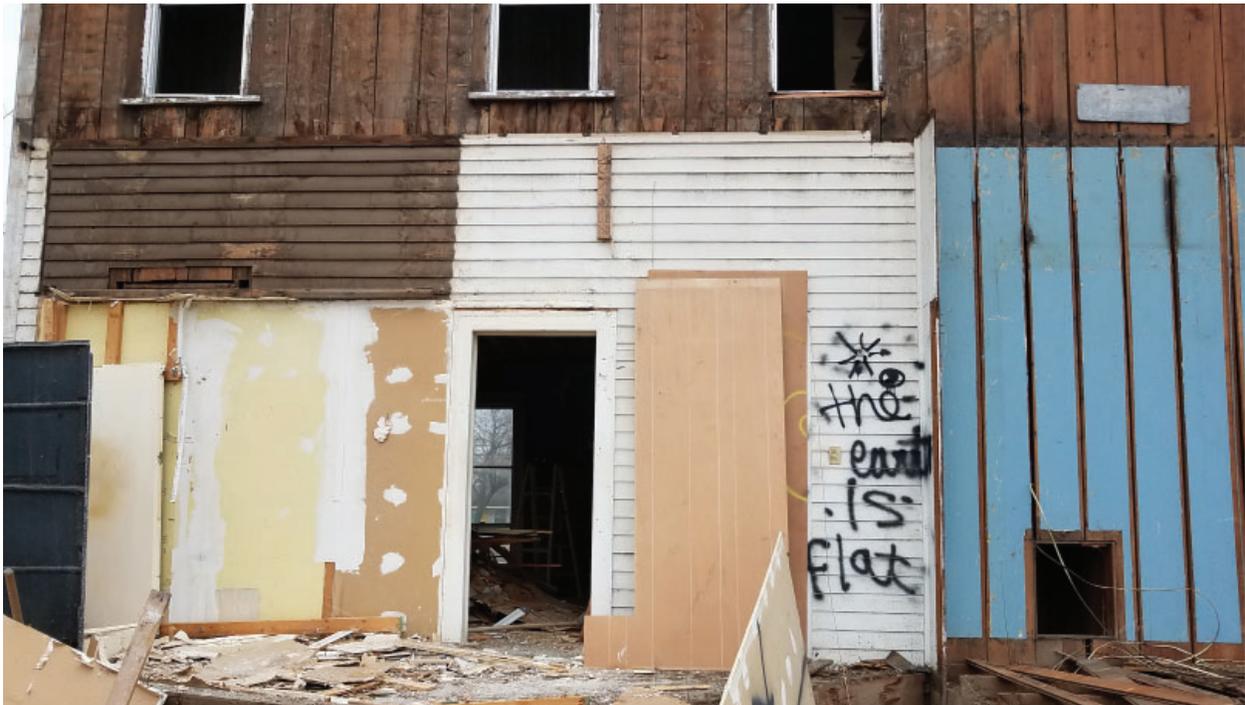
Contrast in the present-day colors of the wall of the kitchen and wall of the dining room, which were painted the same color (above) and the various finishes on the back of the house (below). From left below are the sheetrock wall of the bathroom with unpainted siding above, white painted siding of the enclosed porch and the blue painted boards that are at once the wall of the dining room and exterior of the west living room. The condition of the wood above the blue paint (the wall of the attic above the dining room and kitchen) indicates that the extension was an original part of the house rather than added on later.

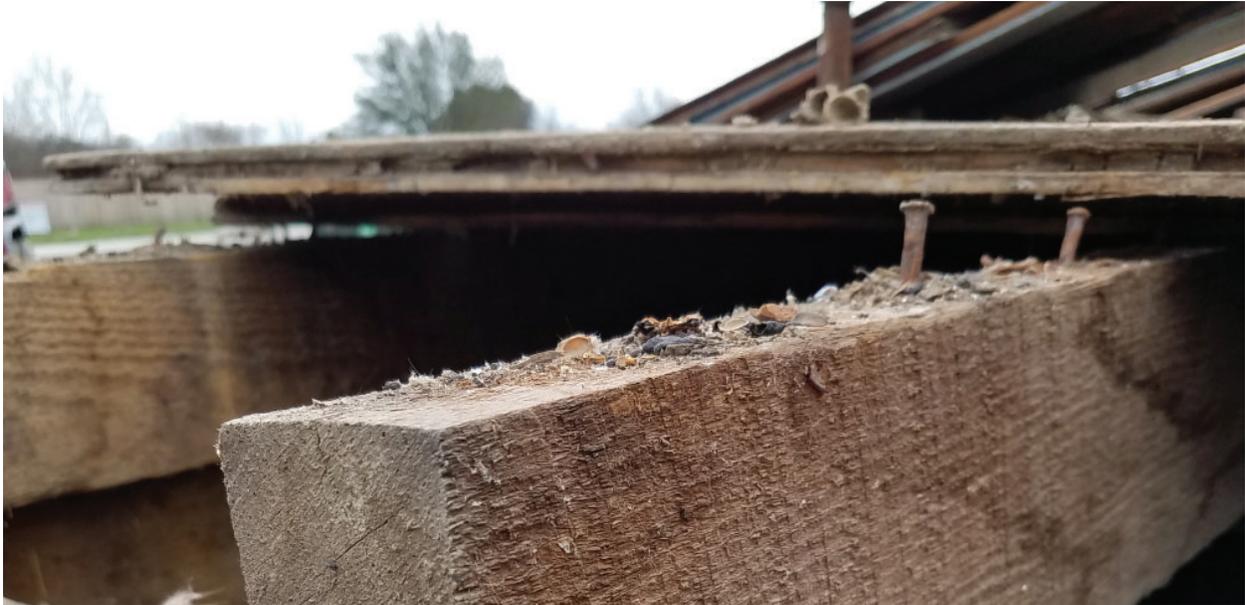
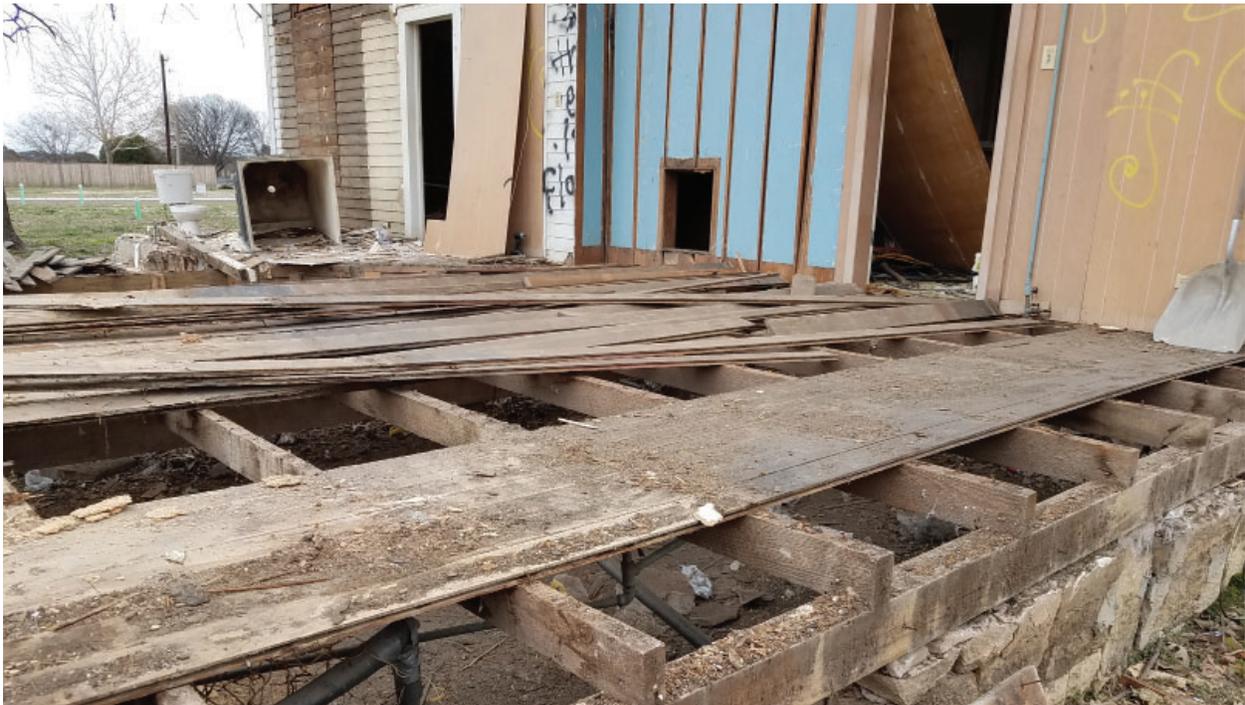
The tongue-in-groove heartwood pine flooring was nailed directly to the 2x6 pine floor joists, The joist dimensions are actual 2x6 and not today's 1½x5½. The joists were nailed to large pine beams that were approximately 3½"x 9", and those rested on the hand-hewn limestone piers, which were set into the ground. The structure, while simple, was incredibly strong, and crafted with quality old-growth wood that is not available on the market today. The stacked stone infill between the stone piers served aesthetic and functional purposes and not structural purposes.

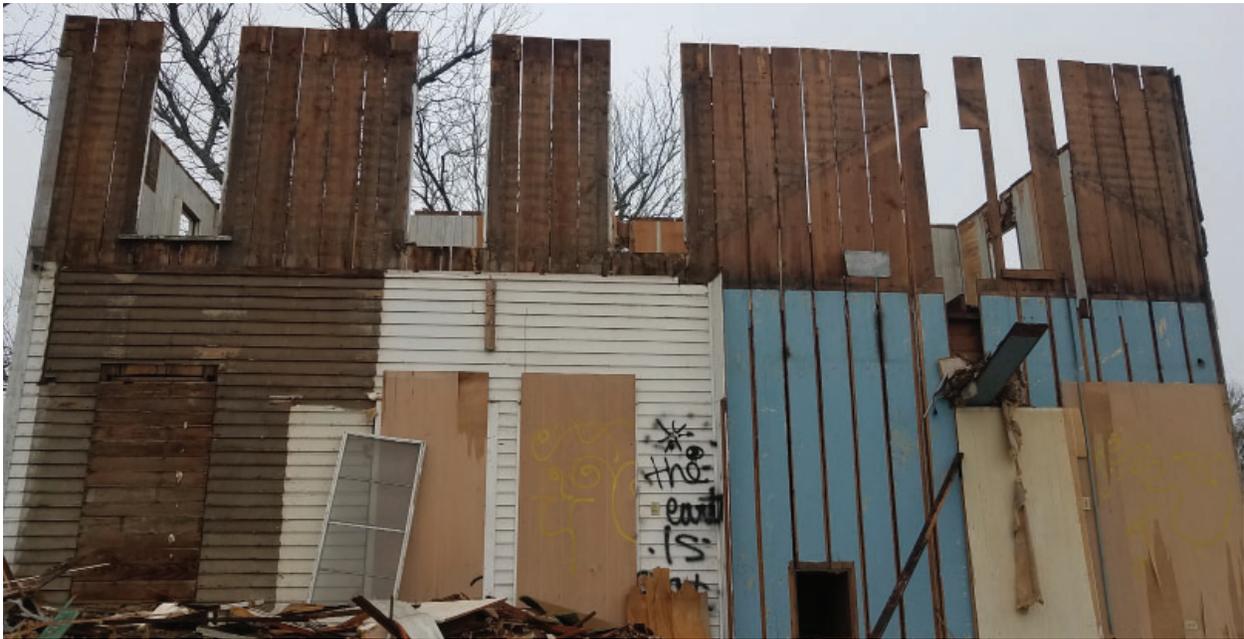
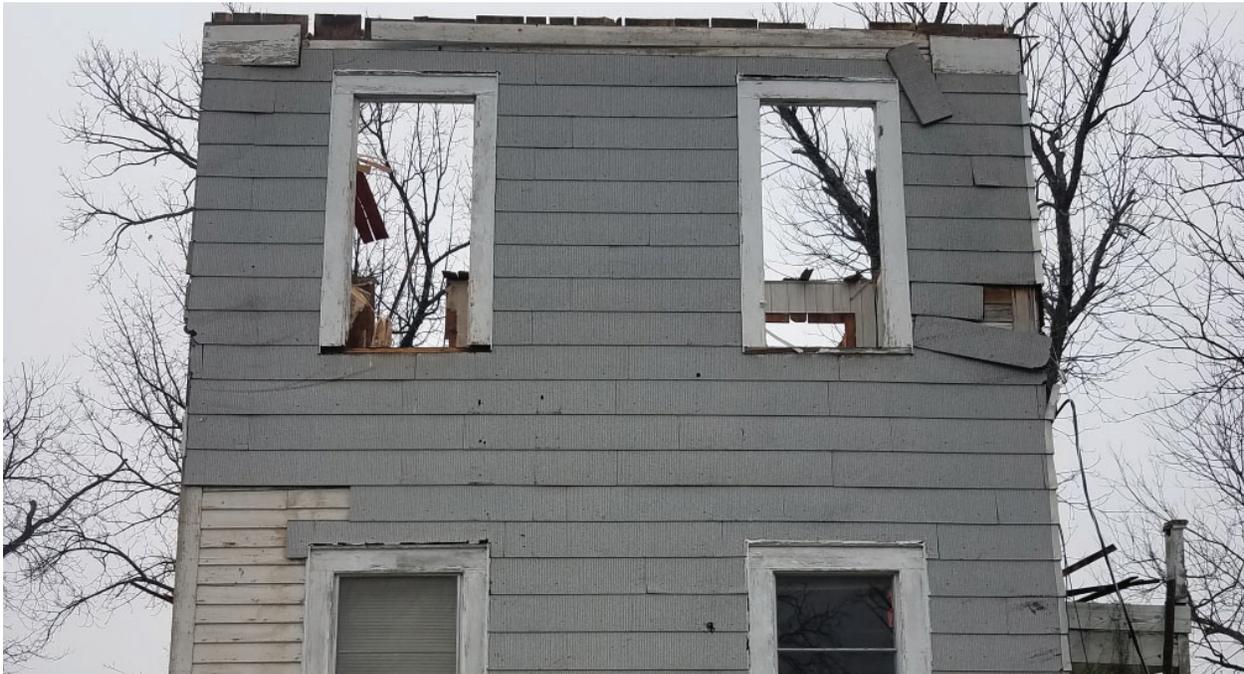
The main portion of the house was constructed like the extension, including the rafters and ceiling joists. It had been assumed that the gable ends would be the full-length 1x12 pine boards, but as it turned out the house was balloon framed with all the same height boards and the triangular gable ends were framed from smaller dimension lumber. It is hard to believe today that a house could be soundly constructed like this, and it is worth noting that the 1x12 lumber served as the second floor interior walls and was only covered by wood siding on the exterior, which accounts for the thinness of the second floor walls.

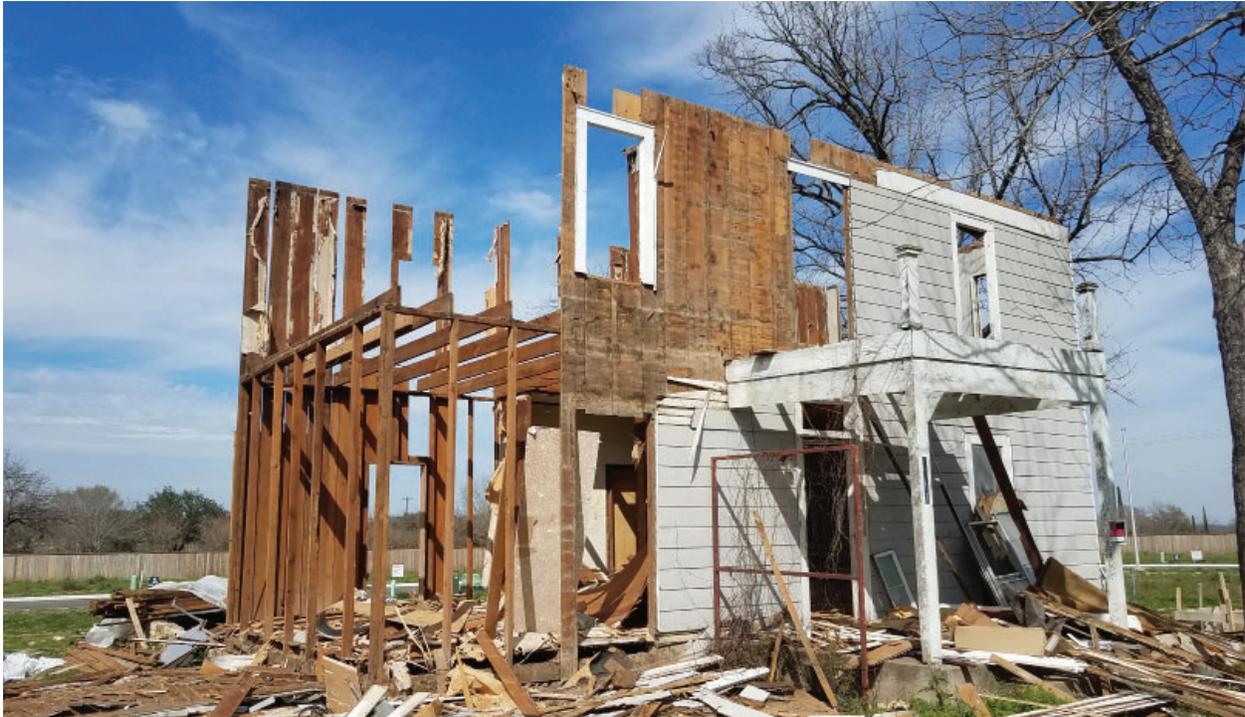
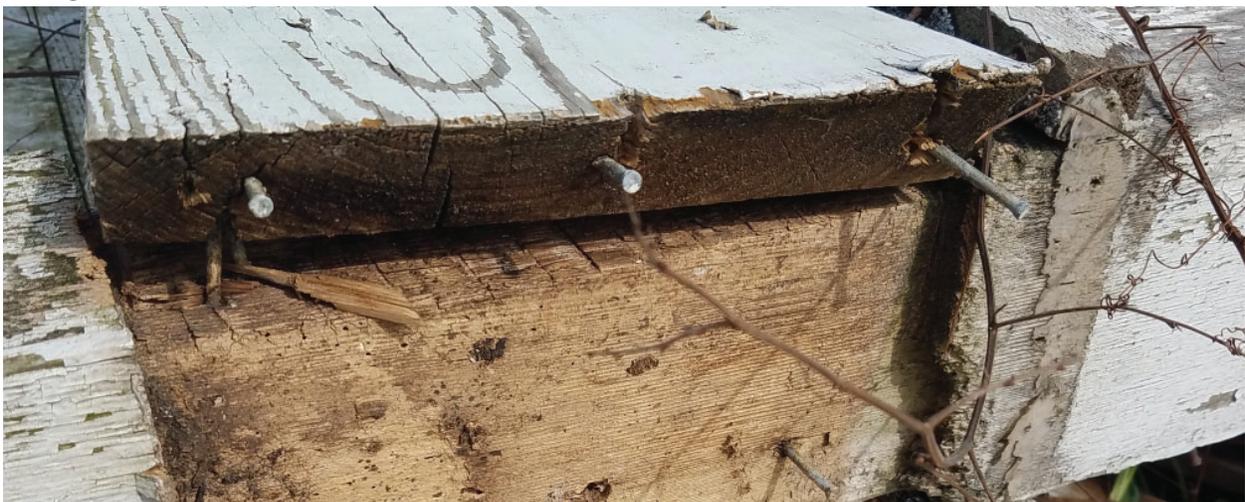
One of the main questions that arose during the initial documentation of the house was whether the house originally had a full-length porch along the front. An aerial photo in the Southwestern University archives from the 1930s was not sufficiently close or clear enough to be conclusive, so when the siding was removed we checked for remnants of a full-length porch or indications that one could have existed. The sills of the first floor windows on the front of the house were set at floor level, which would have allowed one to walk through open windows to the porch - not an uncommon feature for the time. Not only does it appear that there could have been that full-length, two-story porch, the porch that was there is not original. The wood was not as old as the original house, and the nails used to construct it, seen below, were galvanized, which is more in line with the timeframe of the 1966 remodel.

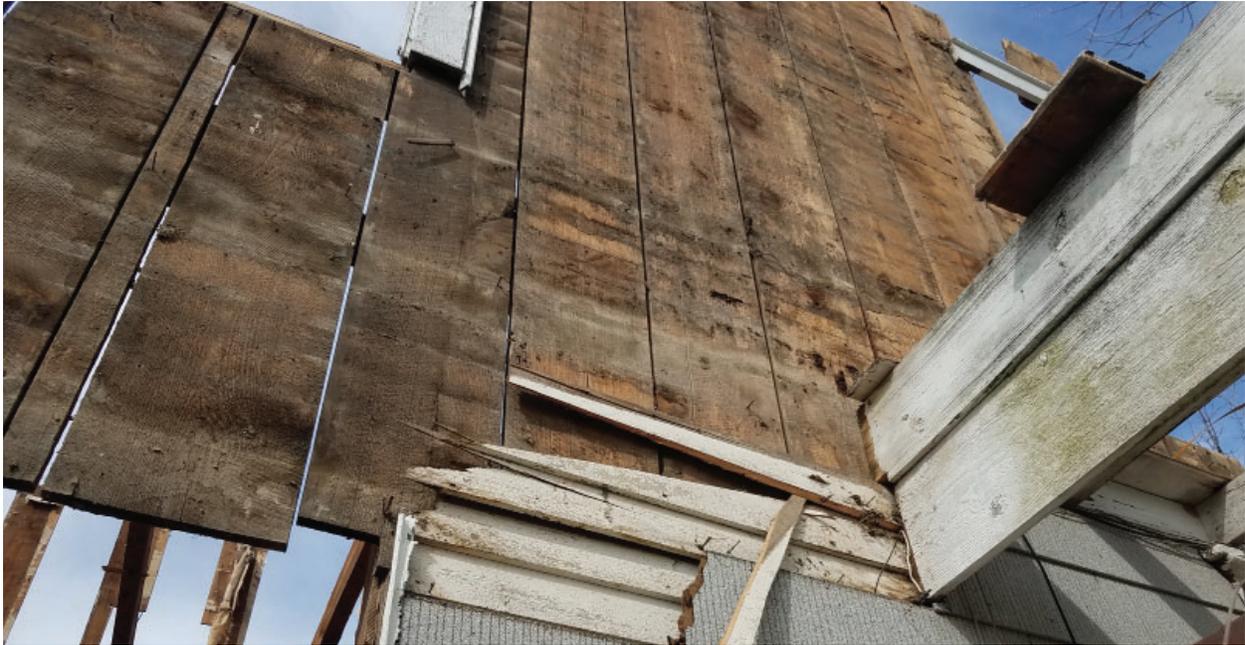
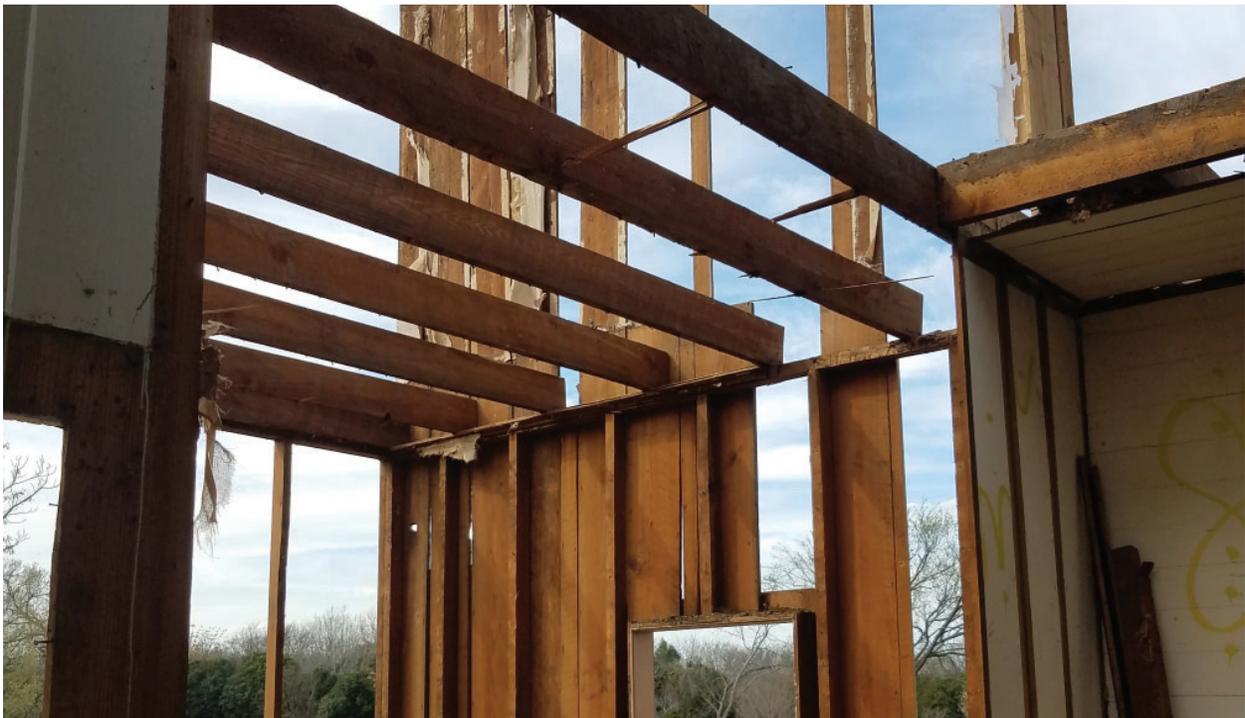
The weathering and coloration patterns of the wood between the first and second stories indicates that a support member may have been set for a porch that spanned the full width of the house and which was accessible from the first and second floors. Below shows the framing supports for the second floor, which essentially created a first floor framing box within the envelope to support the floor joists.

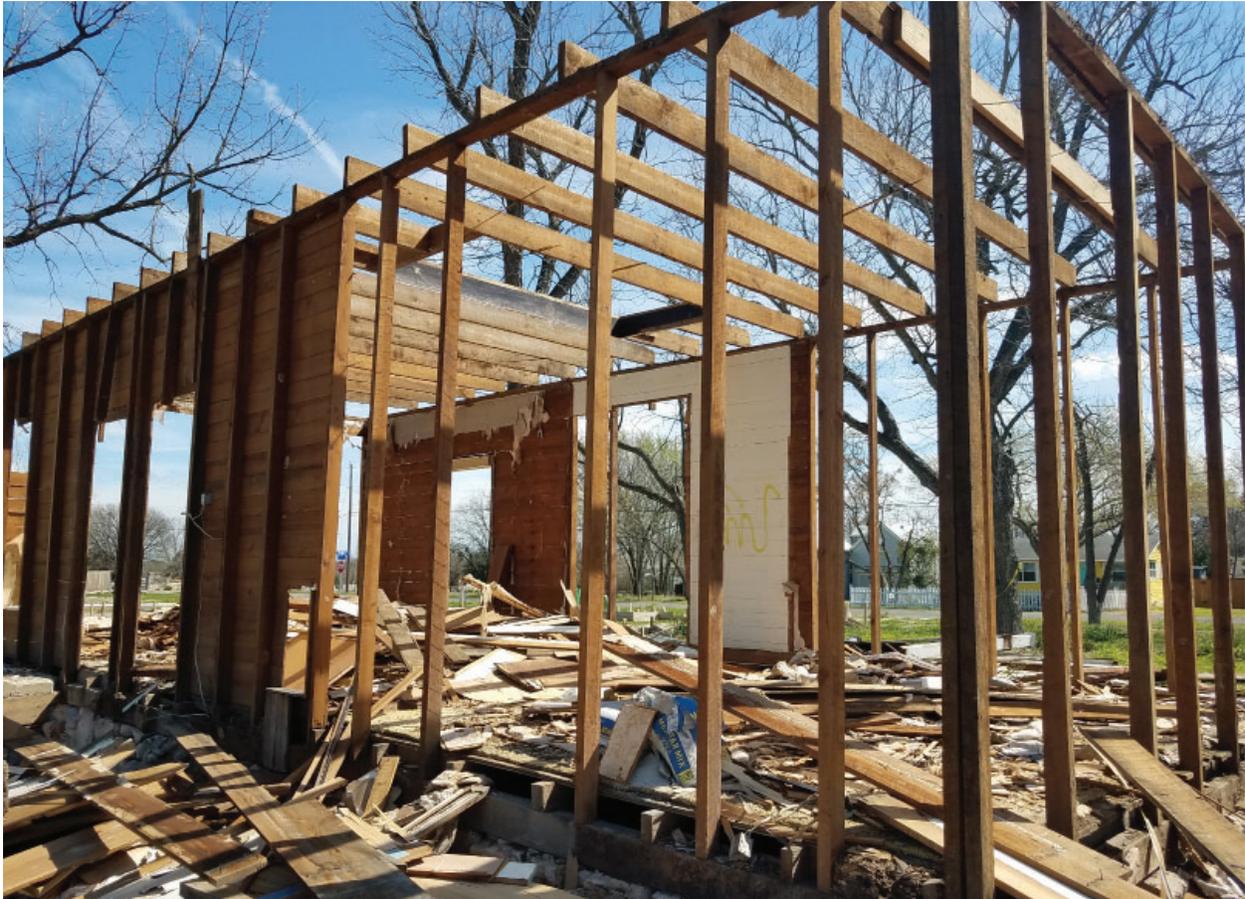
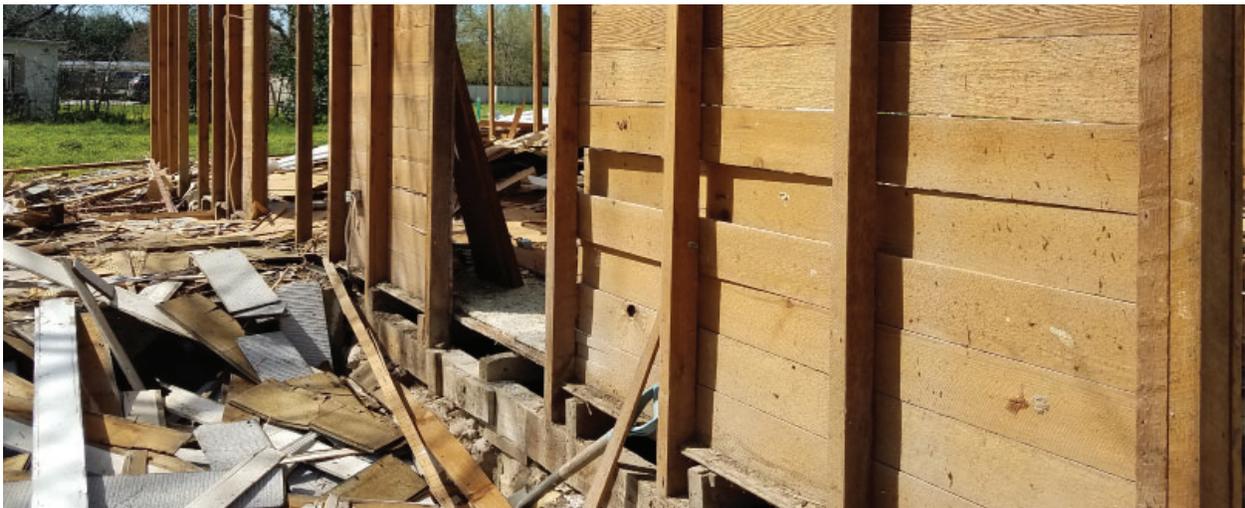
The framing box on the first floor that supported the second floor was lined on the interior with horizontal boards that were later covered with either paint or wallpaper. The wood has been protected from weathering for over a century, turning a beautiful color as it aged.

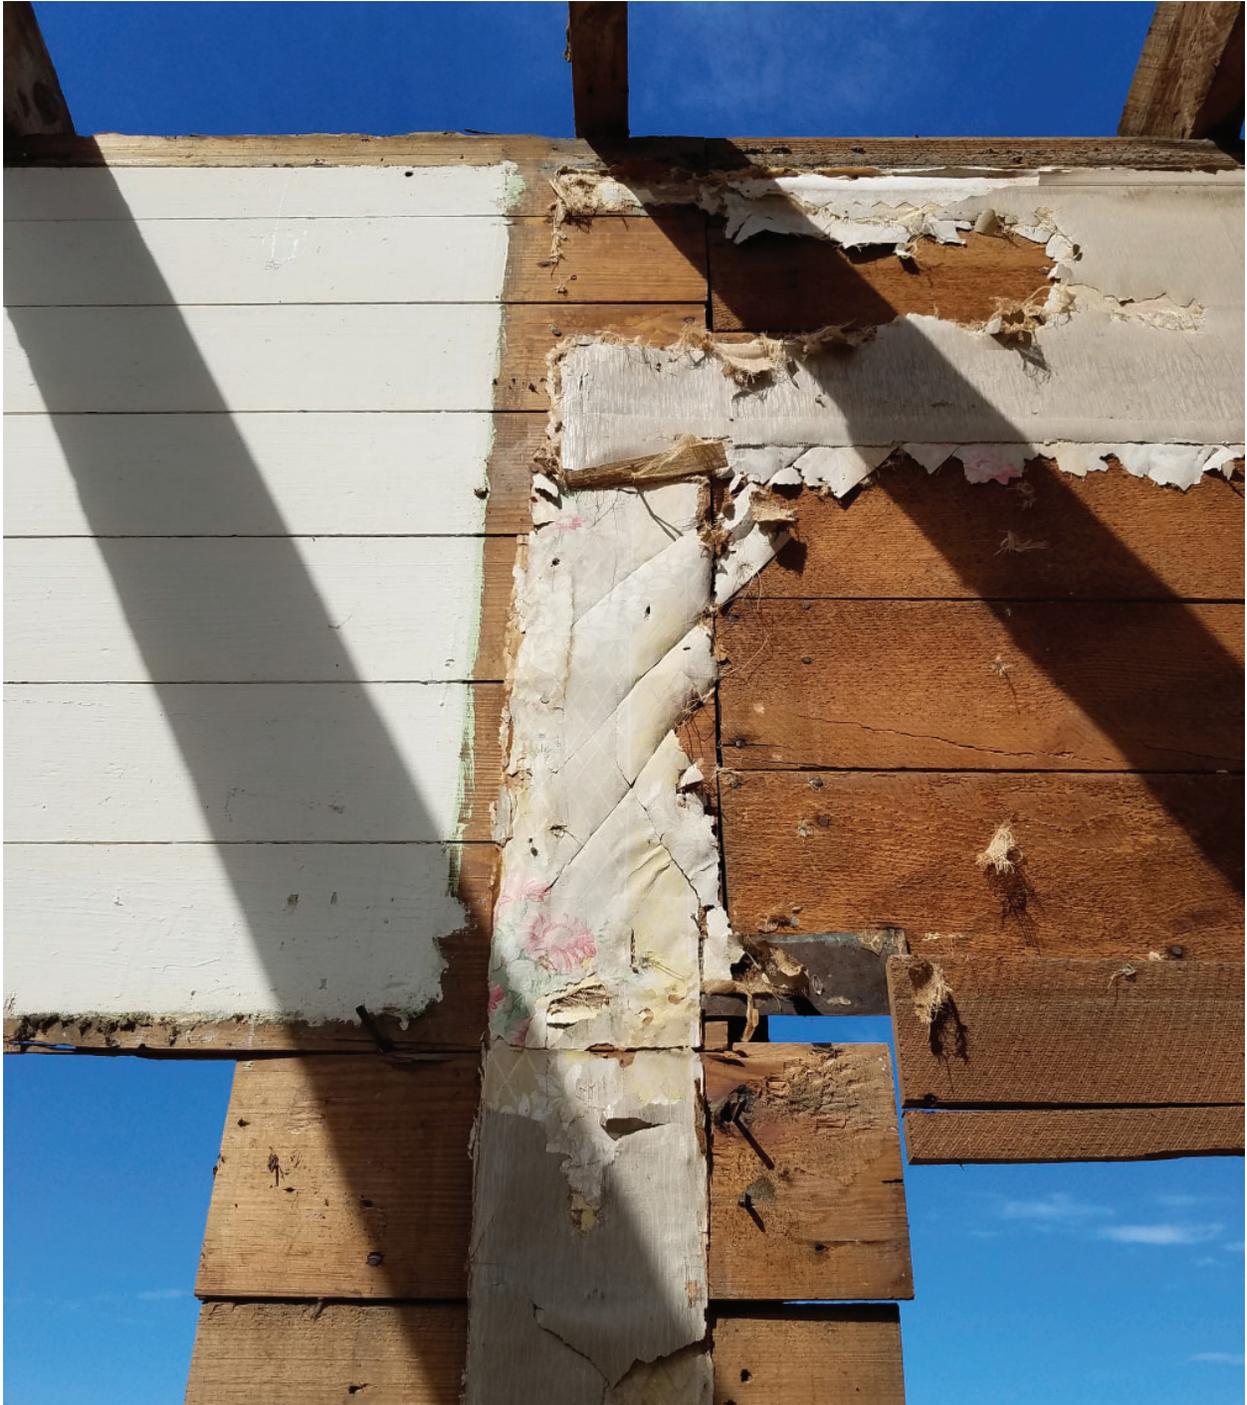
Many textures and colors were layered in the house over the years. This photo is of the wall between the two doors out to the back porch, with the paint on the left from the foyer and the wallpaper from the east living room. The thin dividing line between them was the wall, which was made from two layers of boards.

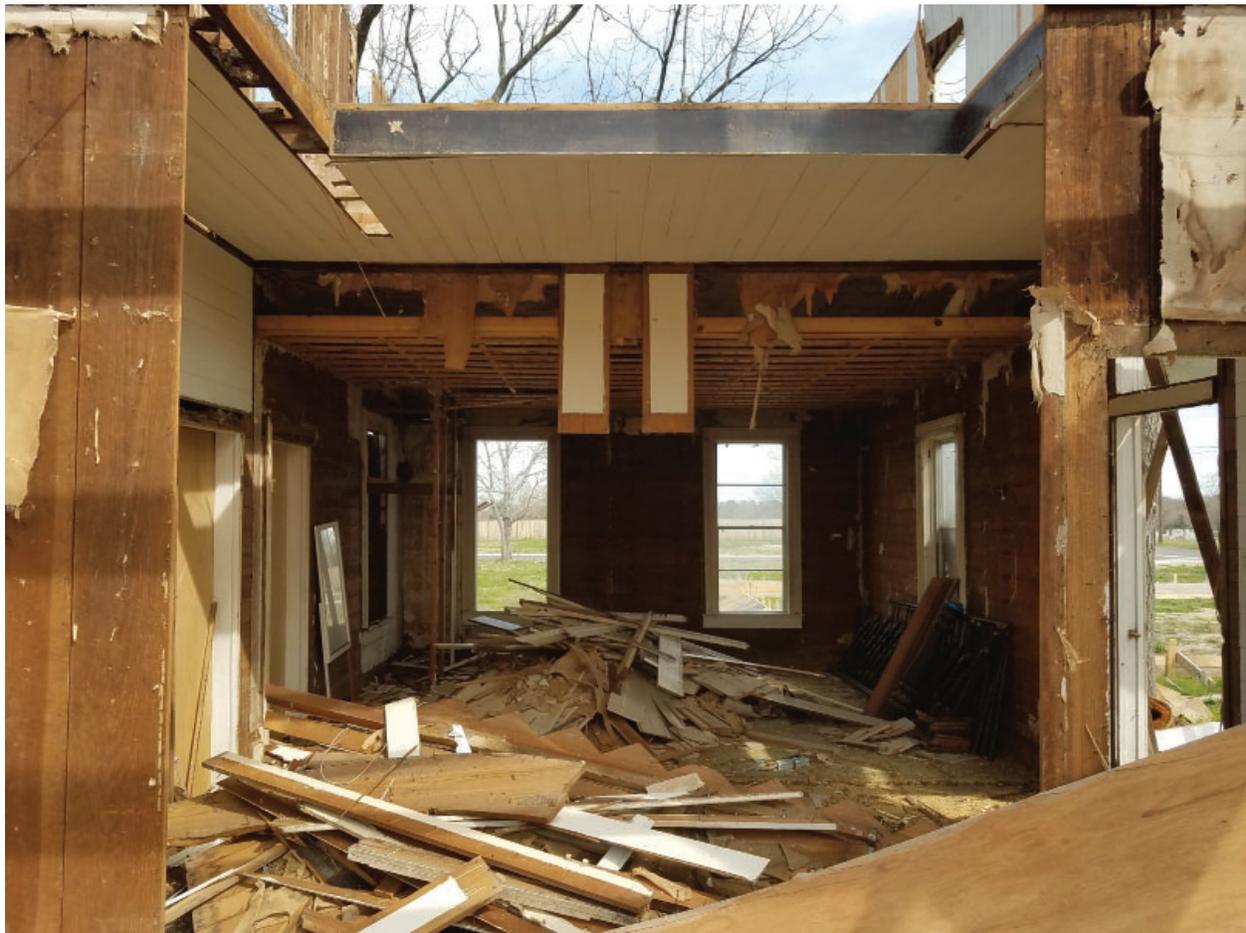
Standing on the west edge of the foundation looking east into the house mid-salvage. There were several layers of wall coverings and in some rooms several layers of floor coverings over the wood floors, which had not all been stained and finished. This century-old home was full of the layers of time.
